Case Study: Carleton Lodge – Recladding for a Better Environment

Tom Sinclair, P.Eng – Halsall Associates Limited
Ashok Malhotra, P.Eng. – Halsall Associates Limited
Brea Williams, Ph.D, P.Eng. – Halsall Associates Limited

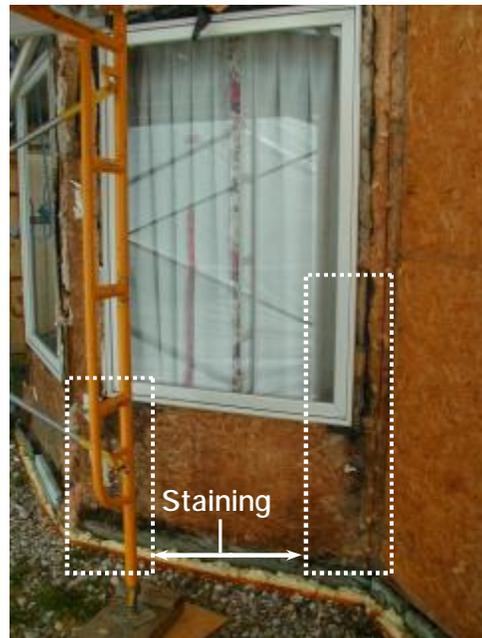
With no soffits, attics had isolated vents in the soffit over the second floor windows. Attic ventilation was poor and icicles formed. Due to lack of an adequate overhang, roof runoff fell to the ground either directly along the wall or by cascading over the shed roofs over the residential washrooms. Some of this water infiltrated the wall assembly through vulnerable areas at the shed roofs, windows, and joints in the siding, and backsplash at the base of the wall (Figure 3). Moisture also infiltrated the wall cavity from the building interior due to spillage of water in bathrooms, leakage from plumbing pipes, and condensation on pipes and exhaust ducts. Condensation in the exterior wall due to high interior humidity was most critical in the common assisted bath areas, where the majority of the fans were not functioning, and not vented to the building exterior. Whenever mould has been encountered since the building was completed, the City of Ottawa (and formerly the Regional Municipality of Ottawa Carleton) has taken immediate action to remove and remediate and conducted frequent air testing to ensure residents and staff were safe.

**Figure 3: Stained Sheathing
Around Windows**

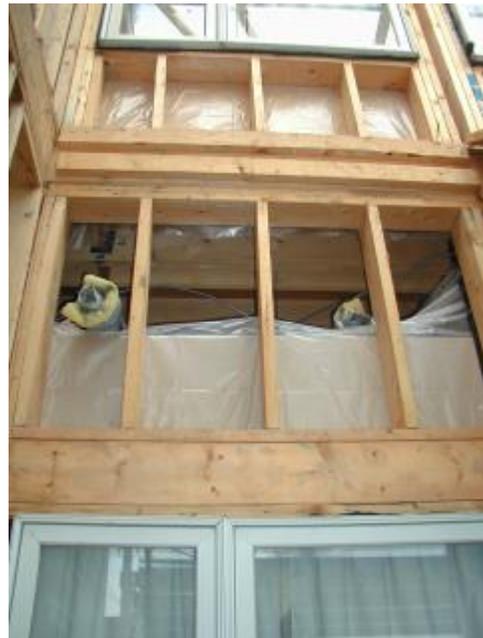
The walls were reconstructed by removing all exterior siding, sheathing and batt insulation. Repairs to the existing 6-mil polyethylene vapour barrier could not be completed due to complexity in the exterior wall design (Figure 4). Since a comprehensive air barrier could be constructed, all efforts were taken to ensure that it was achieved. A new redundant air barrier was constructed with sealed sheathing and a high permeance membrane. The high permeance membrane also acts as a secondary moisture barrier. Batt insulation in the stud cavity was replaced. Based on dynamic hygrothermal modelling by WUFI, additional rigid mineral wool insulation was installed outside the sheathing. Hours per year when conditions support mould growth on the inside face of the exterior sheathing were less than 1% in the analysis. Spray-foam insulation was installed in areas where the vapour barrier could not be reinstated. All of these techniques were aimed at increasing thermal resistance, reducing air leakage, and moisture penetration into the wall cavity, essentially reducing energy consumption and increasing resident comfort.

Figure 4: Discontinuous Poly Layer Between First and Second Floors

The vapour barrier was repaired by sealing holes and providing additional polyethylene where it was missing, prior to any further remediation. Due to the complexity of the exterior wall construction, there was some limitation on the completeness of the repairs to the vapour barrier. New batt insulation (RSI 3.5) was then installed between studs.

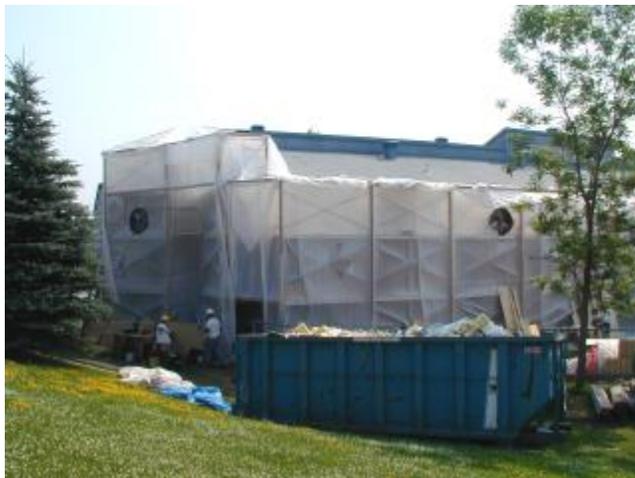
Figure 5: Tarp Enclosure

In order to ensure that the exterior work area was negatively pressurized relative to the interior of the Lodge, each elevation was completely enclosed with scaffolding and a tight tarp enclosure. Large fans through this tarp enclosure operated continuously, creating the negative pressure required to prevent any contaminants from entering the building interior (Figure 5). The interior polyethylene and drywall were maintained during all exterior repairs to keep a defined, exposed separation between exterior and interior. The enclosure also protected the exposed wall construction from rain and extreme temperatures. In instances where the

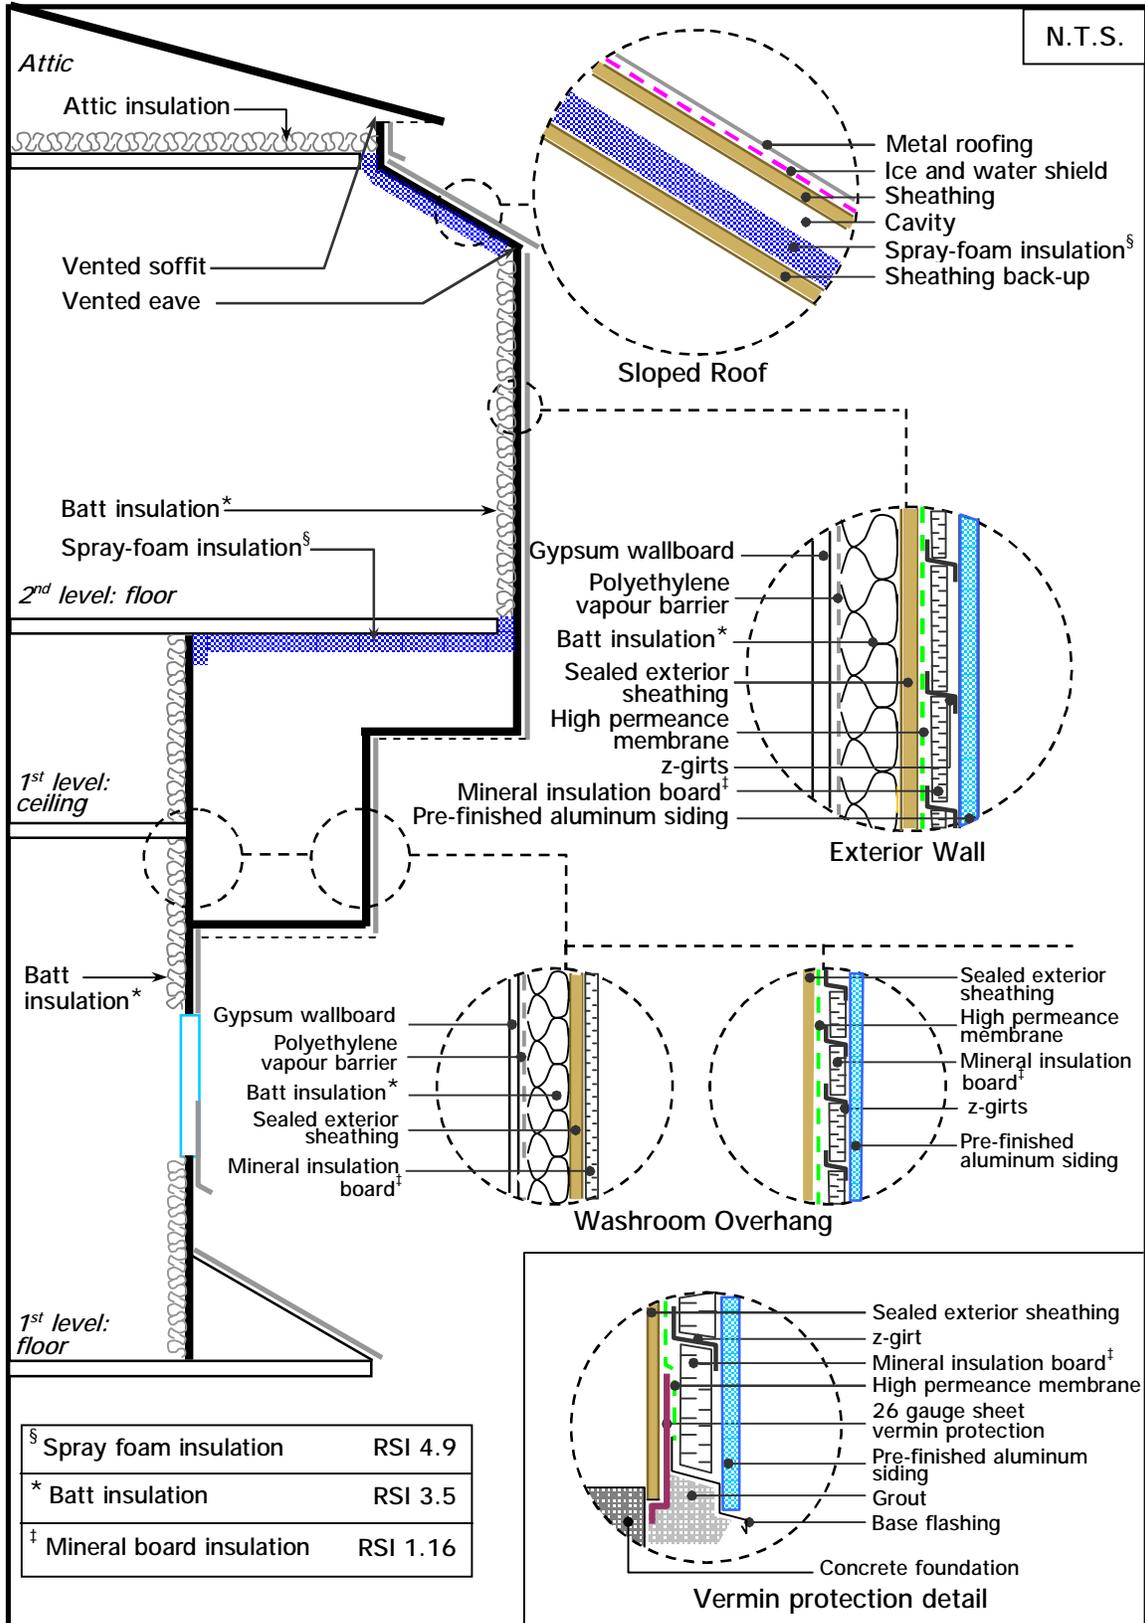
Figure 6: Schematic of Building Section and New Cladding System

Vermin protection in the form of a 22 gauge L-shaped galvanized steel sheet 300mm in height was fastened to the sheathing at the base of the wall, and sealed with grout at its base (Figure 6).

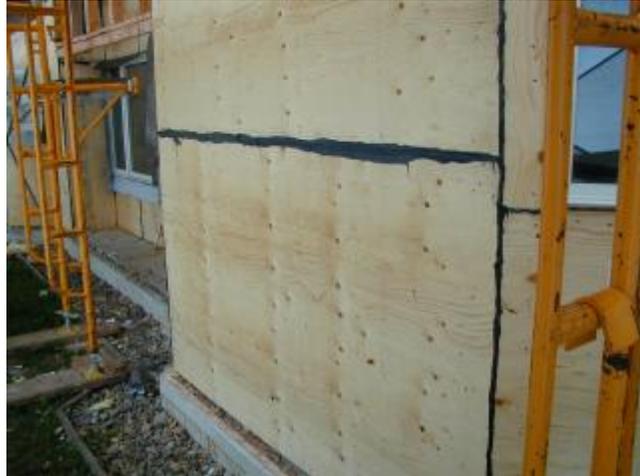
Figure 7: Sealed Joints in Sheathing

The Ontario Building Code (OBC) requires a gap to be provided between sheets of sheathing for new construction. The gap between plywood sheathing boards was sealed with acoustic sealant to the full depth of the edges (Figure 7). Where the acoustic sealant did not appear to fill the entire sheathing joint depth, the joint was taped to maintain the seal. In this way, the sheathing would be the primary air barrier for the building envelope with structural integrity to withstand the pressures developed across the air barrier. Sheet type air barriers can tear or become loose over time. However, since a moisture barrier was needed, and to provide redundancy to the air barrier system, a vapour permeable sheathing was installed over the plywood sheathing and clamped in place with z-girts (Figure 8).

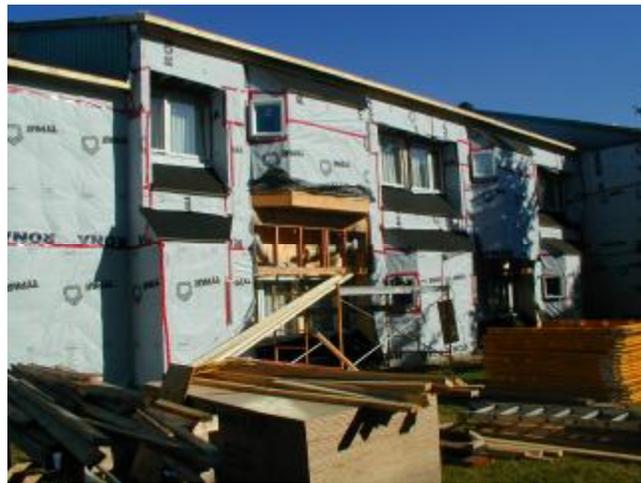
Figure 8: Tyvek Installed Over Sheathing

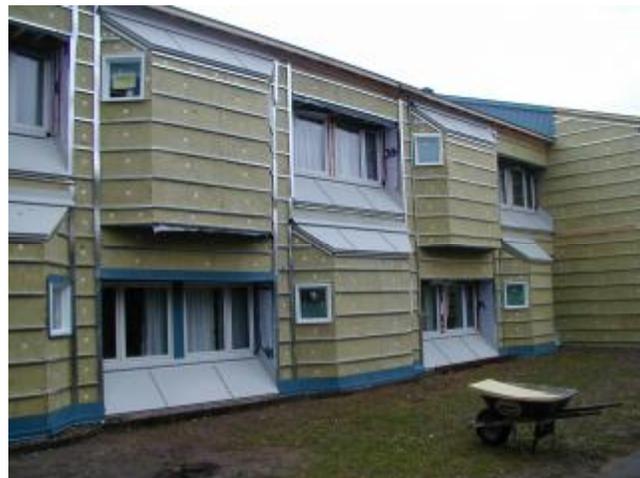
Figure 9: Installation of Rigid Insulation

Next, horizontal galvanized z-girts were installed with a slight slope away from the wall to drain any water away from the wall surface. Rigid mineral insulation board (RSI 1.16) was anchored to the sheathing between the girts to provide a more continuous thermal barrier against heat loss and reduce condensation within the stud cavity (Figure 9).

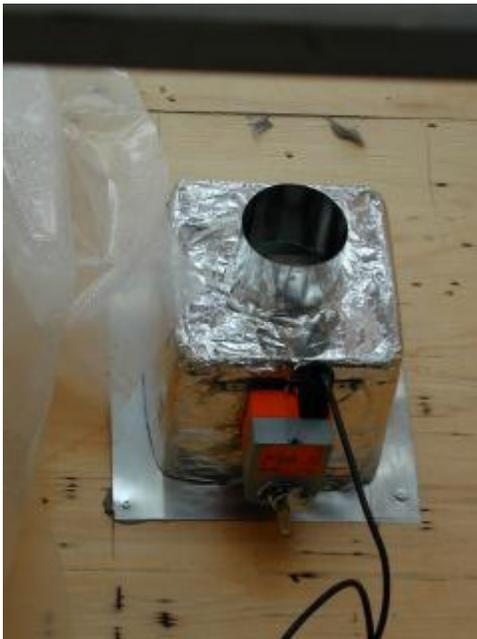
Figure 10: Installed Damper

the integrity of the air barrier, the dampers were sealed with acoustic sealant to the plywood sheathing, and mechanically fastened around their flanges (Figure 10).
