# Energy Conservation Considerations During Building Enclosure Rehabilitation of Large Multi-Unit Residential Buildings

Bonnie Dong, P.Eng.  
Government of Alberta

Warren Knowles, P.Eng.  
RDH Building Engineering Ltd.

Graeme Scott, M.Eng. P.Eng.  
RDH Building Engineering Ltd.

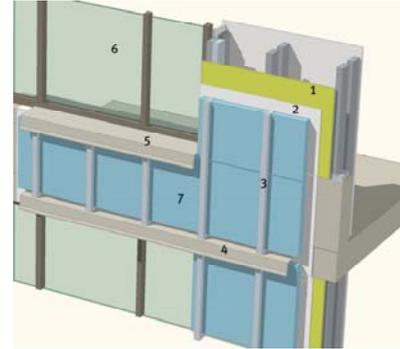
Figure 11. Isometric view of partially rehabilitated wall

1. New fibreglass faced exterior gypsum sheathing
2. New self-adhesive membrane air and moisture barrier
3. Steel z-girts
4. Cross-cavity flashing
5. Window sill flashing
6. New window assembly
7. Rigid or semi-rigid exterior insulation

The new girt assembly is attached to the existing structure, using angle shaped clips and shimmed, bolted connections, minimizing the thermal connectivity of the girts with the now exterior insulated concrete building frame. These supports are designed so that the attachment points have been made at the top and bottom of the girts, leaving the stucco support thermally broken along the majority of its length, eliminating the typical z-girt to metal stud framing connections.

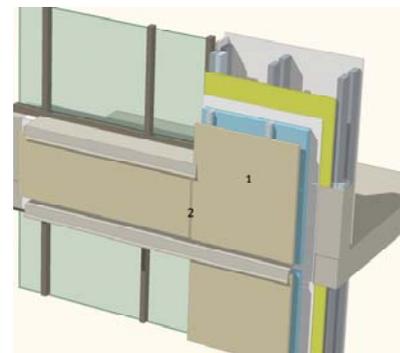
Figure 12. Isometric view of rehabilitated wall, all layers.

1. New stucco cladding
2. Control joint / sealant

Figures 11 & 12 conceptually show the multiple layers of the rehabilitated stucco wall, and the continuity of the new thermal insulation over the concrete building frame. These figures also show the girt assembly passing below the window bands, which was later revised (see below).

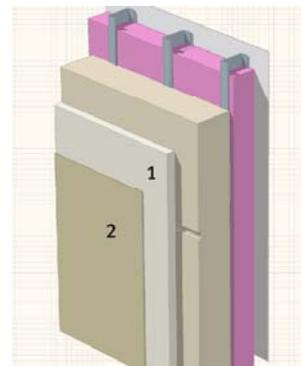
Figure 14. Isometric view EIFS cladding

1. Polystyrene insulation on vapour permeable, water resistive cementitious barrier
2. Reinforced cementitious base with acrylic finish coat

consideration of the vapour permeability of the entire wall assembly. Specifically, unlike metal stud framed exterior wall assemblies, where removal of the exterior sheathing provides access to remove an existing polyethylene vapour retarder (from the outside), the concrete wall areas can only be cost effectively rehabilitated from the building exterior. Therefore, a thermally improved, rehabilitated wall assembly was designed to manage wetting and drying effects (direct wetting/drying and vapour diffusion), with the existing polyethylene vapour retarder remaining in place. To achieve this, a vapour permeable cementitious membrane and an adhesively attached, drained Exterior Insulation and Finish System were selected (see Figures 13 and 14).

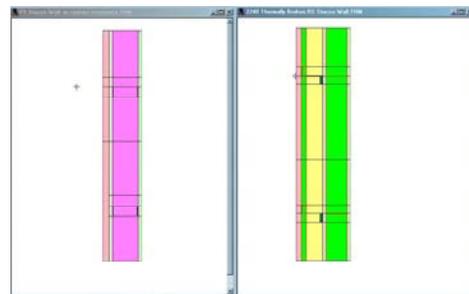
The effects of minimizing thermal bridging in the wall assemblies is illustrated in Figure 15. The rainscreen stucco was designed and installed so that the girts that are supporting the stucco lath are connected only at the top and bottom of each girt to the building frame. Therefore the model in Figure 15 shows the predominant conditions between points of attachment to the building structure. The results of 2-D thermal modeling using the software model THERM, shown in Figure 16 indicates the interior temperature is cooler at the stud location for a typical wall as compared to the thermally isolated rainscreen wall. Providing the thermal break for the framing supports lowers the potential for stud shadowing to occur and contributes to increasing the effective thermal resistance of the wall assembly.

Figure 15 LHS: Cross section of typical face-sealed stucco wall assembly. RHS: Cross section of rainscreen stucco wall assembly

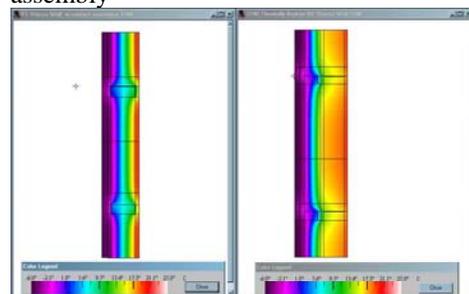
Figure 16. Colour isotherms of assemblies in Figure 14. Temp. ext. = -6 °C, and Temp. int. = 21°C.

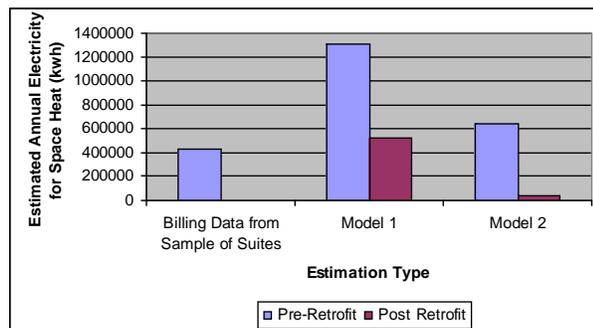
There is a large amount of variation between the modeling predictions and the estimate taken from billing data shown in Figure 19. There are too many unknown variables to obtain an accurate picture of the effect that this retrofit may have on space conditioning energy requirements at this time. By examining actual billing data from other rehabilitated buildings, these unknown variables can be better determined and incorporated into the modelling.

In both of the models, the values of the air leakage used in the models affects the variability in the predicted energy requirements the most. The proportion of heat loss attributed to air leakage as compared to heat loss through the enclosure is shown in Figure 18 for Model 1. The values of air leakage in this model are taken from literature values for the pre-retrofit case and from field measurements for the rehabilitation case (Ref. 2).

Figure 17. Comparing before and after retrofit electricity requirements for space heat estimated using two models to an estimate of electricity purchased for space heat from billing data. Model 1 is by calculation and Model 2 is using eQUEST.

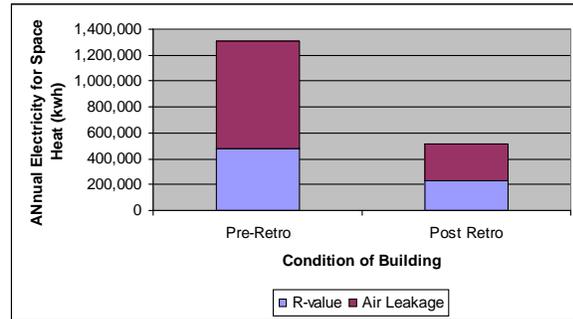
Figure 18. Breakdown of Model 1 components for space heat requirements into heat loss through enclosure (R-value) and heat loss through air leakage

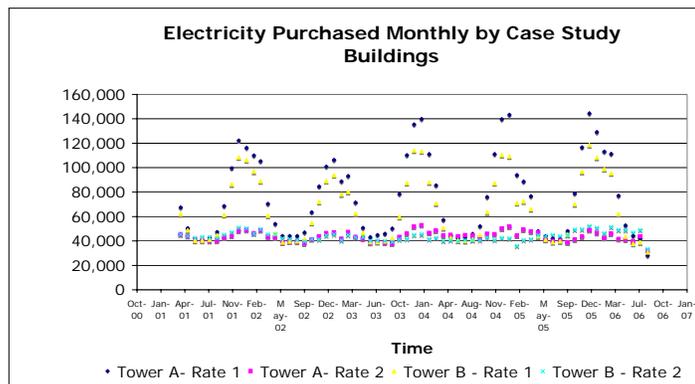
Electricity billing data was provided by the utility provider for 5 years prior to the rehabilitation construction, with construction taking place into early 2007. Based on the monthly electricity billing data in Figure 19, there appears to be season peaks that correlate with the heating season. The baseline, or electricity purchased shown as Rate 1, can be assumed to be plug load or electrical load that is not contributing to space heating requirements. The electricity purchased at Rate 2 appears to be for space heating requirements. From Figure 19, the amount of electricity purchased annually is closer to the estimate provided by Model 2. Additional years of post rehabilitation utility billing is required to further assess the effect that leaky condo rehabilitation has on electricity for space conditioning.

Figure 19. Monthly electricity consumption for each of the high-rise buildings of the case study complex. Rate 1 is residential rate, Rate 2 is commercial rate.
