# Partial Rehabilitation: The Challenges of Tying-in a Drained Glazing System with a Face-Seal Wall System

*A high-rise building located in Vancouver was diagnosed with water penetration at the window-wall system. The opaque walls were clad with panelized, face-sealed EIFS. The investigation found no major deterioration in the EIFS area and it was decided that the rehabilitation would include only the replacement of the window-wall system. Retaining the existing, face-seal EIFS in place brought on a number of challenges:*

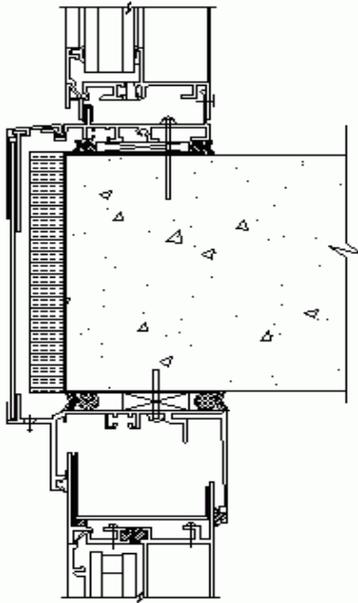
Figure 3: Existing window head and sill detail

For this particular project, the existing window-wall was actually a punched window installed from slab to slab with a metal panel at the slab edge. Figure 3 shows the sill and head detail for the existing window. The window had a 3-inch thick aluminum frame installed flush with the face of the slab. The frame was set over a U shaped clip at the sill, which was fastened down to the slab and abundantly sealed but did not incorporate end-dams. At the head, the frame was set into a deflection header, which was also set in caulking. The slab edge was covered with liquid applied membrane and semi-rigid insulation. The metal panel was protruding from the glazing system. At the jamb, the frame was oversized, extending a few inches behind the EIFS. This is illustrated in Figure 4.

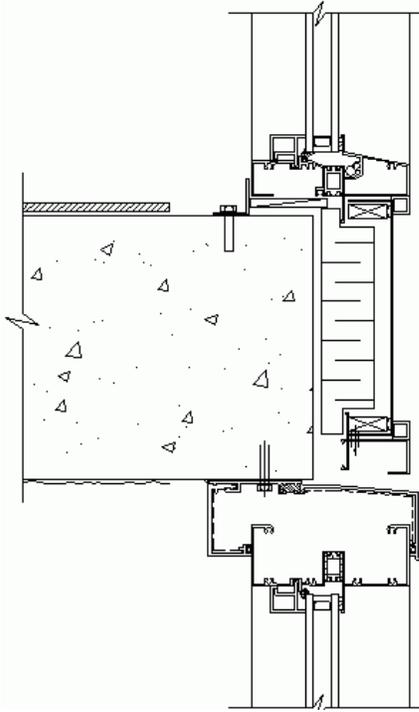
Figure 5: New window-wall head and sill profile and position

The new glazing system is a modern window-wall with a split frame overhanging the slab edge and creating a spandrel section. The frame between the slabs is 4 ½ inches thick and is installed to overhang at least 2 inches past the edge of the slab (refer to Figure 5). At the front of the slab, only the front half of the frame continues down to the next window. This is typical of most window-wall systems available in Vancouver. It gives very little flexibility in terms of the position for the window.

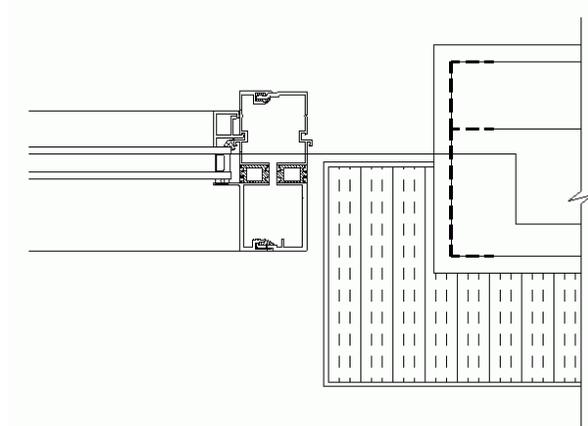
Figure 6: New window-wall jamb profile and position

Moreover, the window frame could no longer fit behind the cladding at the jambs. This created a gap at the window jamb, exposing the edge of the EIFS panel to the interior (refer to Figure 6). How to deal with this space, and more specifically how to connect the window critical barriers to the wall assembly was the most important challenge. This was especially complicated given that the EIFS did not incorporate a secondary or internal moisture barrier.

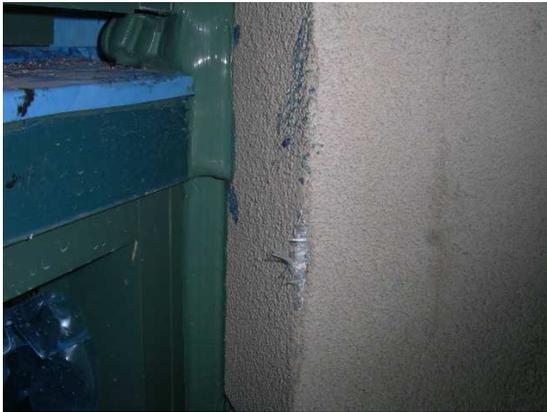
The jamb detail presented above was developed with this in mind. Instead of modifying the EIFS to continue the window up to the original position, the window was kept back to the face of the existing EIFS. Nevertheless, damage to the EIFS was unavoidable. Since the existing window frame was hard to remove and abundantly caulked in place, the removal of the window frame inadvertently caused some damage as the workers pried their crowbars on the EIFS lamina or simply, during the removal of the caulking, pulled away the EIFS lamina (refer to Photo 1).

*Photo 1: Damage to the existing EIFS*

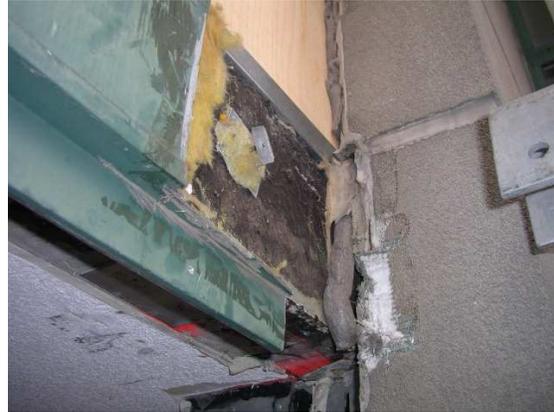
*Photo 2: Existing condition of the EIFS*

In addition to the damage caused by the removal of the window, there was pre-existing damage to the EIFS. The majority of this damage was related to the installation of the EIFS panels around the slab edge metal panel of the existing window. Since the metal panels were installed first and they ended up extending beyond the face of the EIFS return at the window jamb, the prefab EIFS panels were notched to fit the metal panels (refer to Photo 2).

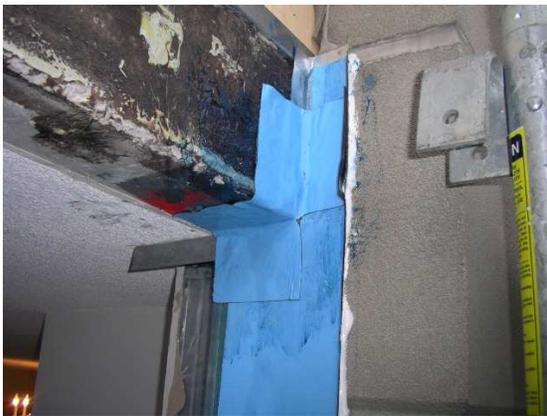
*Photo 3: Window-wall to EIFS / window installation below.*

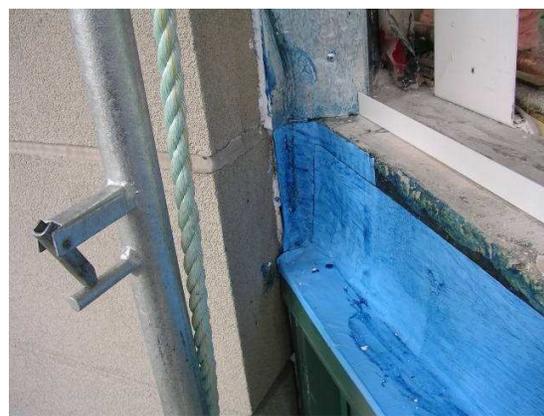
*Photo 4: Window-wall to EIFS / window installation above*

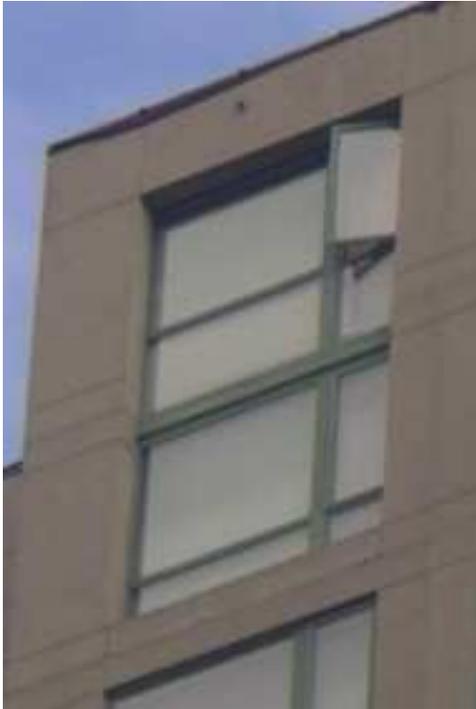
The existing details that were causing problems and needed to be replaced were the slab by-pass conditions. Because of the lack of end dams and the way the windows were secured in place, most of the damage was happening at these locations. Any window with the problematic by-pass condition was therefore included in the scope of work. Some of the windows incorporating these details were not spanning all the way to the slab above or below (refer to Photo 5 and Figure 9). These were referred to as the double window-wall and were mostly located at the upper floors of the building. The challenge with those windows was to efficiently separate the EIFS from the window-wall at the head so that contamination could be prevented. This was impossible without removing some EIFS.

*Photo 5: Double window-wall at upper floors*

During the course of construction, it was also discovered that the steel studs located at the front of the concrete up-stand at the base of these windows were, in some cases, badly deteriorated. Therefore, more EIFS needed to be removed. Eventually, it was decided that the upper three floors of the building, which incorporated most all of the double window-wall located in the face seal EIFS would be fully rehabilitated.

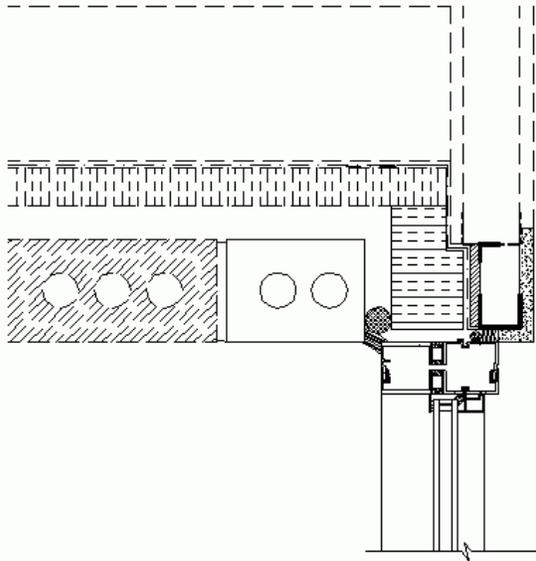
Figure 10: Double window-wall in brick

This was a direct consequence of the EIFS being a face-seal system. Because there is no moisture barrier membrane behind the cladding, there is nothing to naturally tie the window into, especially at the head where gravity is at work. The more vulnerable nature of the face-seal system also influenced the decision. Case in point, the double window-wall units located at lower floors were found in a brick veneer that incorporated a secondary moisture barrier. These were easily replaced with the new system with minimal tie-in problems (refer to Figure 10).
