DEVELOPMENT OF A RAIN SCREEN SYSTEM FOR ADHERED MANUFACTURED STONE

Robert Rymel I.P. Eng.

11th Canadian Conference on Building Science and Technology
Banff, Alberta, 2007

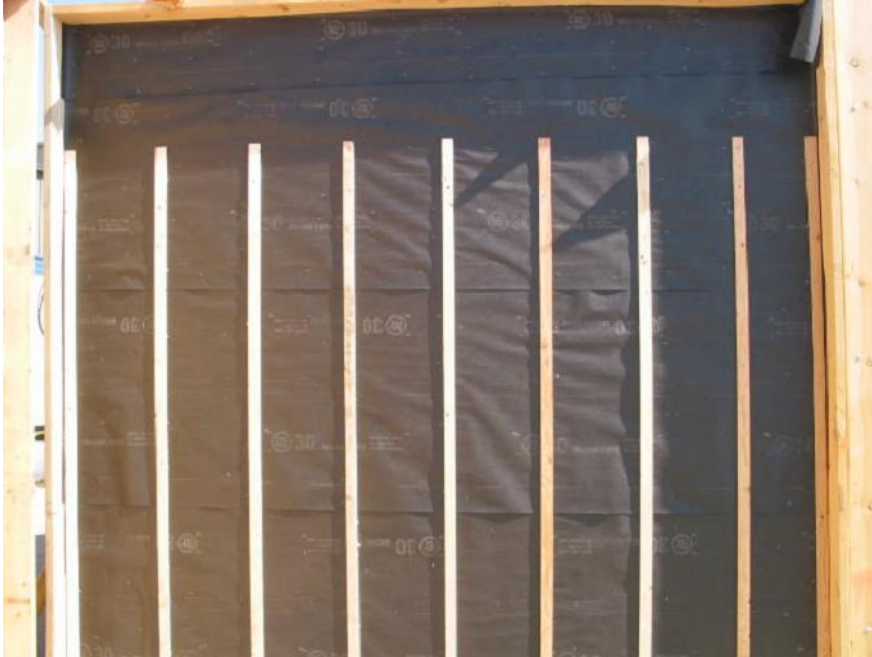
Photograph #1 – Test panel with strapping applied

A matrix was develope d outlining the p ossible com binations of materials to achieve a w orkable solution. The materials were readily available and installed using a n ormal constr uction practice. Of some co ntroversy was the means of strapping. Since practices varied s omewhat geographically from rip ping plyw ood or OSB, to using dressed thin lum ber, the decision was made to co rrespond to the mea ns most cost effective on site, which was the ripping of OSB sheets to approximately 75mm widths.

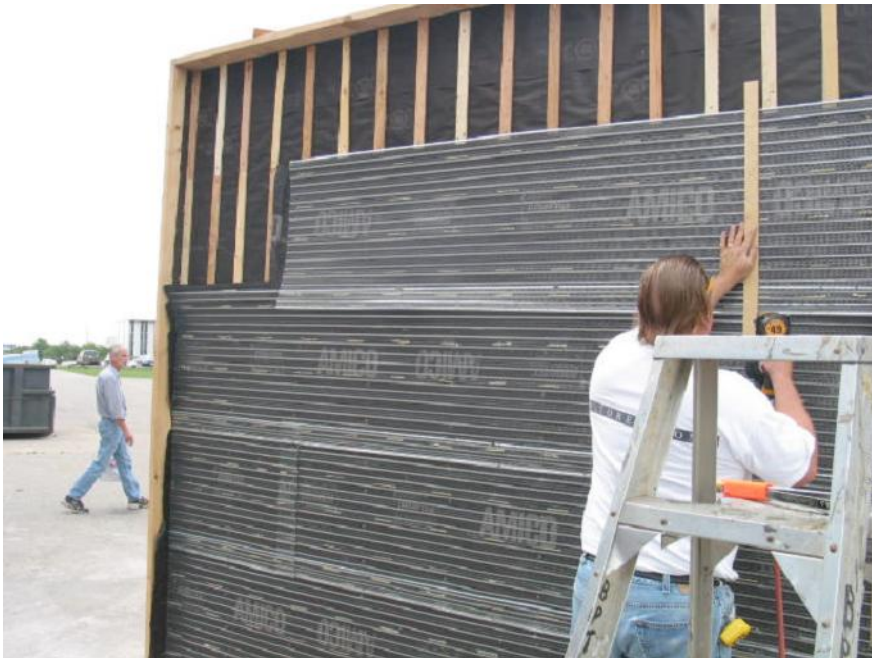
Photograph #2 – Paper backed lath being applied

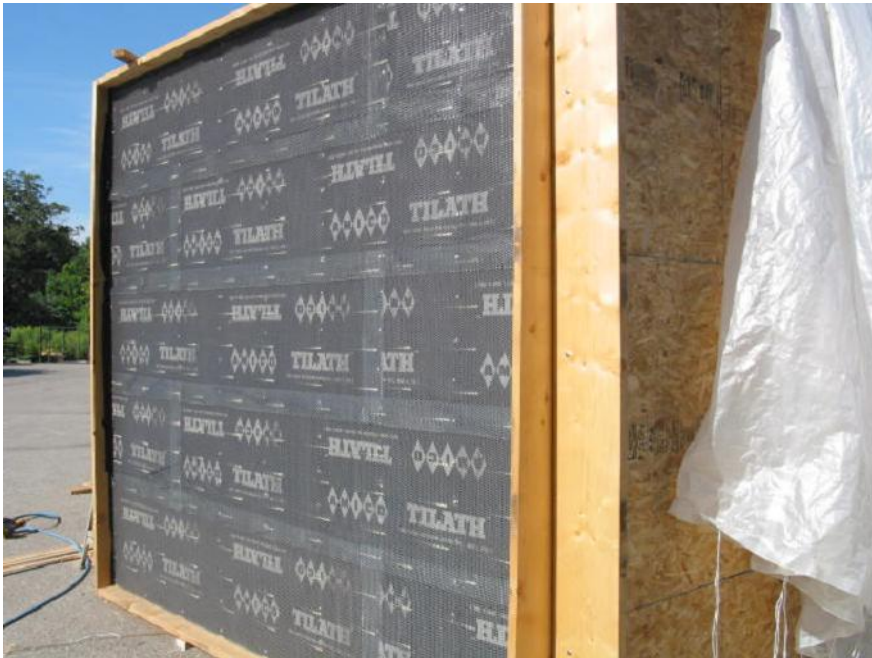
Photograph #3 – Completed application of paper backed lath

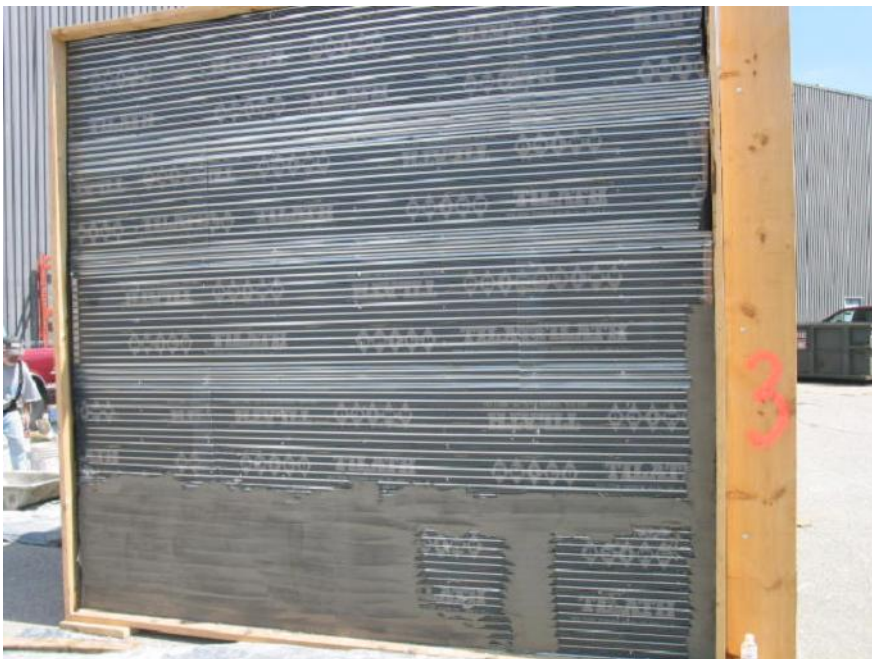
Photograph #4 – Start of scratch coat application of mortar

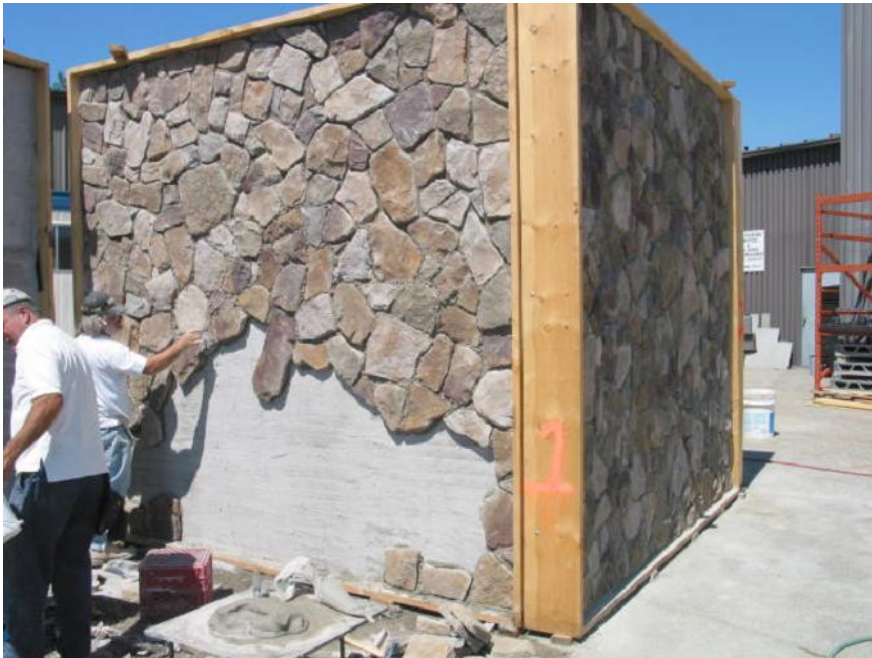
Photograph #5 – Application of manufactured stone

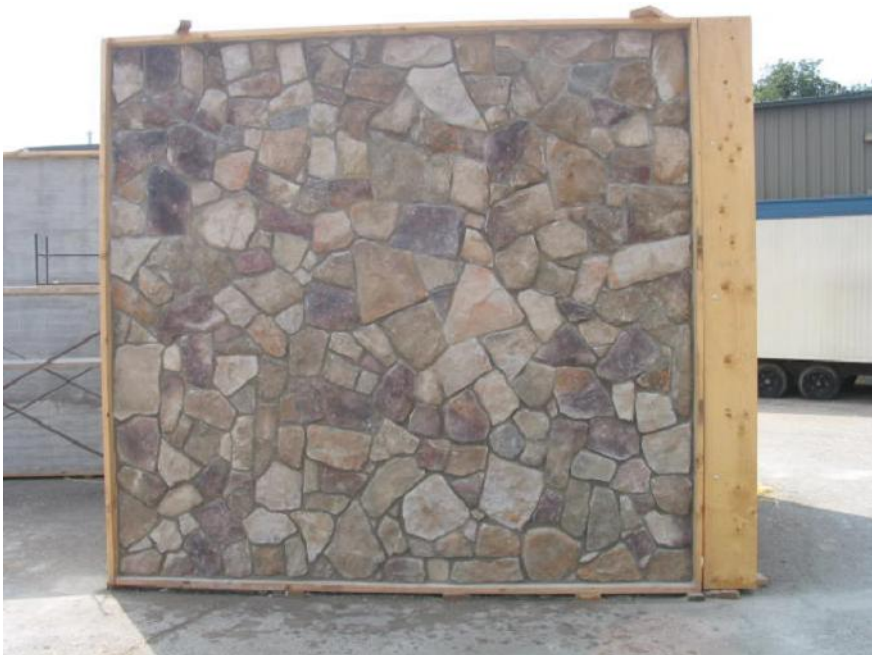
Photograph #6 – Completed panel

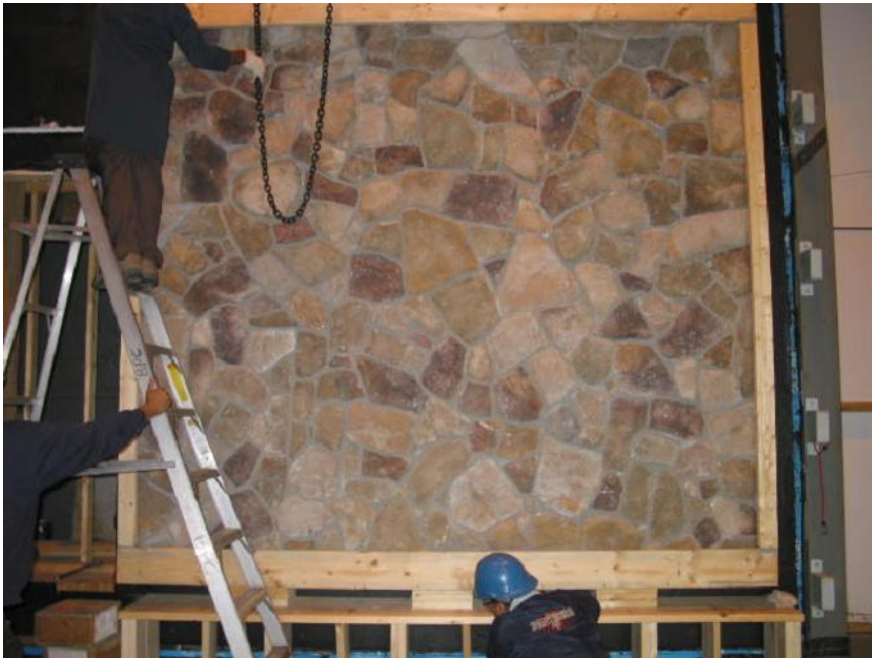
Photograph #7 – Panel mounted against test chamber

In order for the panel to be mounted into the test Chamber, a wood "buck" was constructed as part of the panel and as per the pattern laid out by the Technical Guide. Once curing time of 28 days was complete, the assembly was mounted such that stone faced into the chamber which made monitoring difficult. Failures could only be surmised based on the inability to establish or maintain the necessary pressures. Even once the pressure testing was completed the panel had to be removed to carry out a visual inspection for cracking or stone delamination.

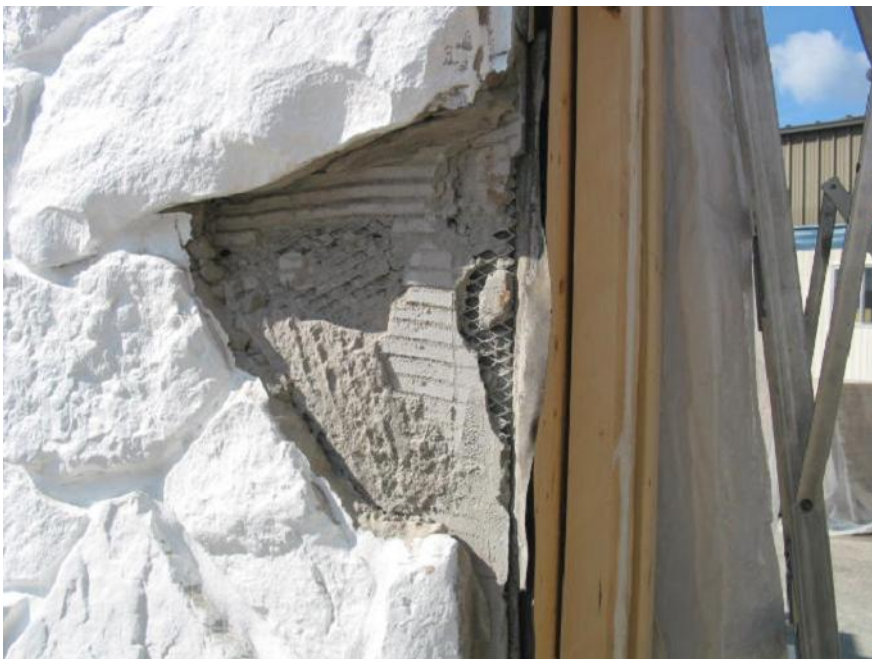
Photograph #8 – Typical failure of Panels #1 to #3

In each case the panels were able to withstand the initial cycling pressures and therefore demonstrated relatively good fatigue strengths. Specimens #1 through #3 however, failed under the deformation loads. The pressure at which failure occurred increased as the specimen strengths increased, as would be expected.

The three dimensional cone shape deformation which occurred during the testing resulted in a rotational component of the forces acting on the cladding and stone. This rotation occurred primarily at the perimeter of the specimens and was verified by the fact that the failures of Specimens #1 to #3 occurred at the perimeter. The stone and mortar was expected to flex outward following a curvature from top to bottom as well as from side to side. This rotation was also a partial cause of failure.
