Hybrid Rain Screen and Face Seal Enclosures “The About-Face of Rain Screen Systems”

Martin J. M. Gevers, P. Eng. BEP

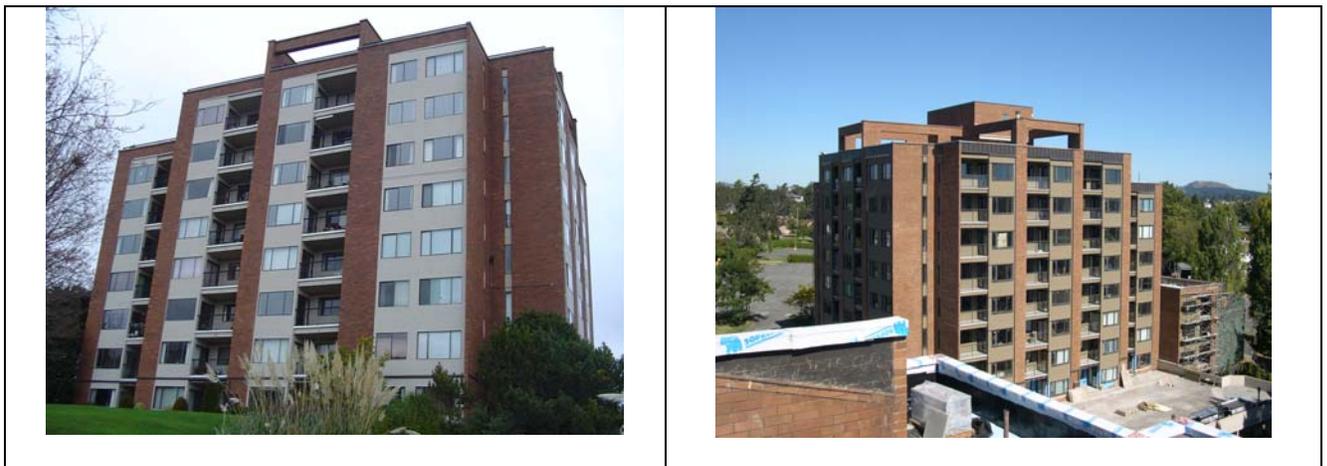
Figure # 1: Elevation view of unclad reinforced clay masonry wall and infill stucco façade. The photo at left has the original face seal stucco panels and the photo at right has rain screen stucco with flashing over-cladding around the perimeter of the stucco panels. The masonry was re-pointed and sealed but remained unclad. There were typically more than a dozen interfaces on each level of each façade.

Most designers appear to agree that the exterior-insulated, pressure-moderated, rain screen wall assembly that replaced the face seal infill stucco panels on this building is the preferred system for exposed conditions. The confidence in such a rain screen wall upgrade can be put in jeopardy however when a non-rain-screen assembly is to be connected with a highly-trusted (and perhaps warranted) assembly with only a membrane separating them. In addition, the concrete floor slab was regarded as an untrustworthy potential bridge or conduit that could introduce water to the warranted pressure-moderated rain screen walls to which they are intimately connected.

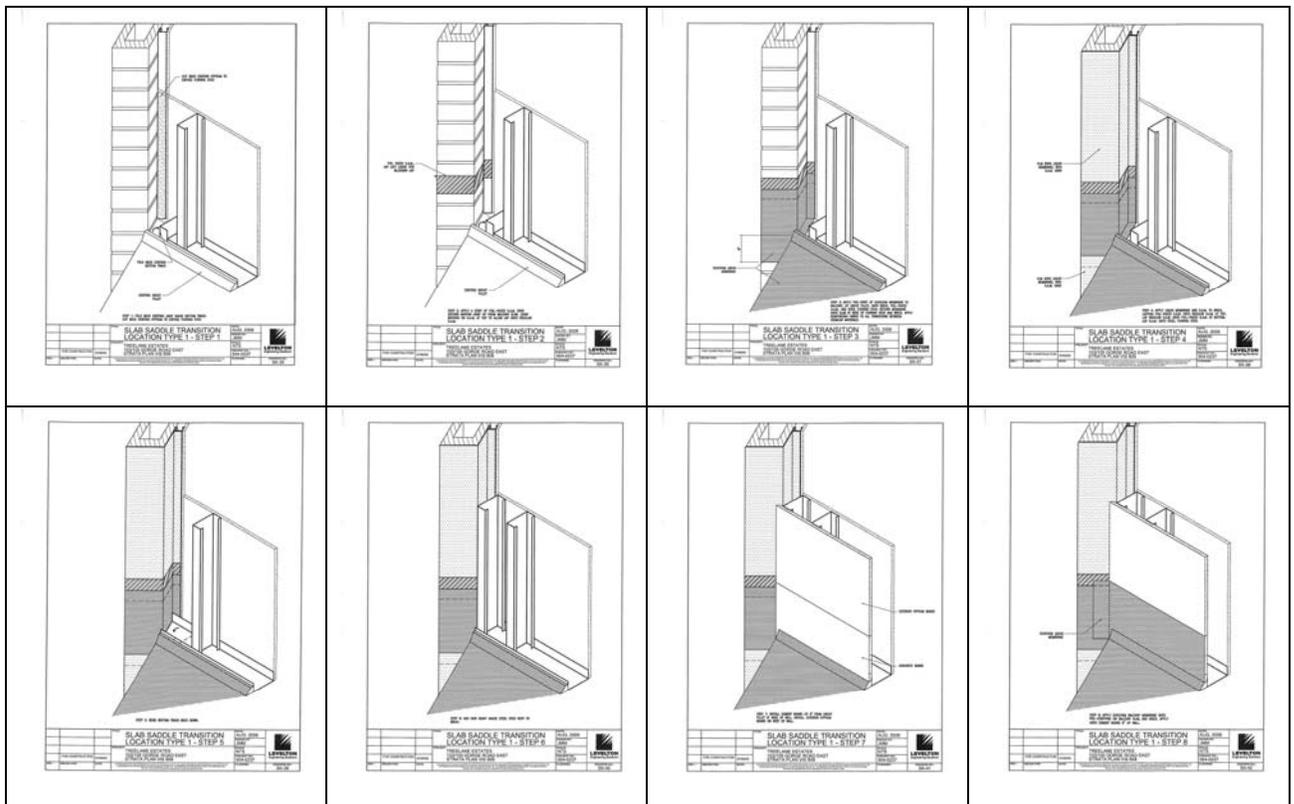
Detailing Layer by Layer

Figure # 2: 8 of 16 three-dimensional sequenced details to direct the installation of only one of many types of interfaces between the face seal brick structure and the rain screen steel stud and stucco infill wall. The complexity of the geometry, materials compatibility issues, potential for error are always present when complex details such as these are being constructed. Also implied in the many layers of application is the amount of overlap and hence low coverage efficiency of the membranes used at the hybrid interfaces.

- The remedial work required a high level of engineering detail to clearly communicate the complex interfaces. (Figure 2 shows a small sample). This situation could be improved by undertaking a reasonably large scale pilot project in cases such as this when the underlying structure and connection details are not known. This would provide a superior basis for detailing and experimentation with solution alternatives that could also be communicated and reviewed by the risk reviewer. In summary: it appears that remediation of hybrid enclosures should involve a pilot project prior to preparing the final remediation contract documents. The high level of detailing would be developed during the pilot project.

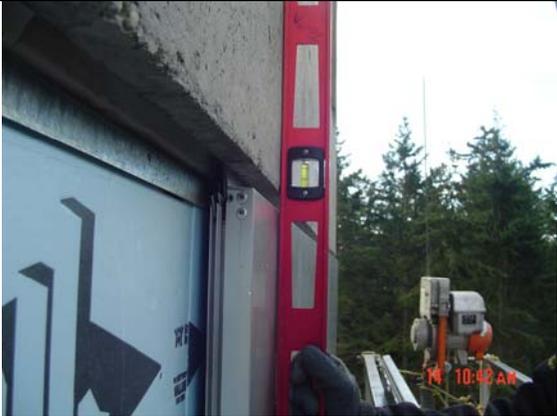
<p>Figure # 3: Photo of Metal Panel Wall on Steel Stud and Gypsum Sheathing Infill Wall Properly Aligned Flush with Face Seal Concrete Surrounding Wall.</p>	<p>Figure # 4: Photo of Metal Panel Wall on Steel Stud and Gypsum Sheathing Infill Wall Improperly Aligned with Exposed Perimeter.</p>

The system was designed with the metal panels to be perfectly in-plane with the concrete face. The concrete conditions at the perimeter of the rain screen panels relied on this to provide the detailed interface between the air-tight back of the panel system and the edge of the concrete to which it was sealed.
