Case Study: Carleton Lodge – Recladding for a Better Environment

Tom Sinclair, P.Eng – Halsall Associates Limited
Ashok Malhotra, P.Eng. – Halsall Associates Limited
Brea Williams, Ph.D, P.Eng. – Halsall Associates Limited

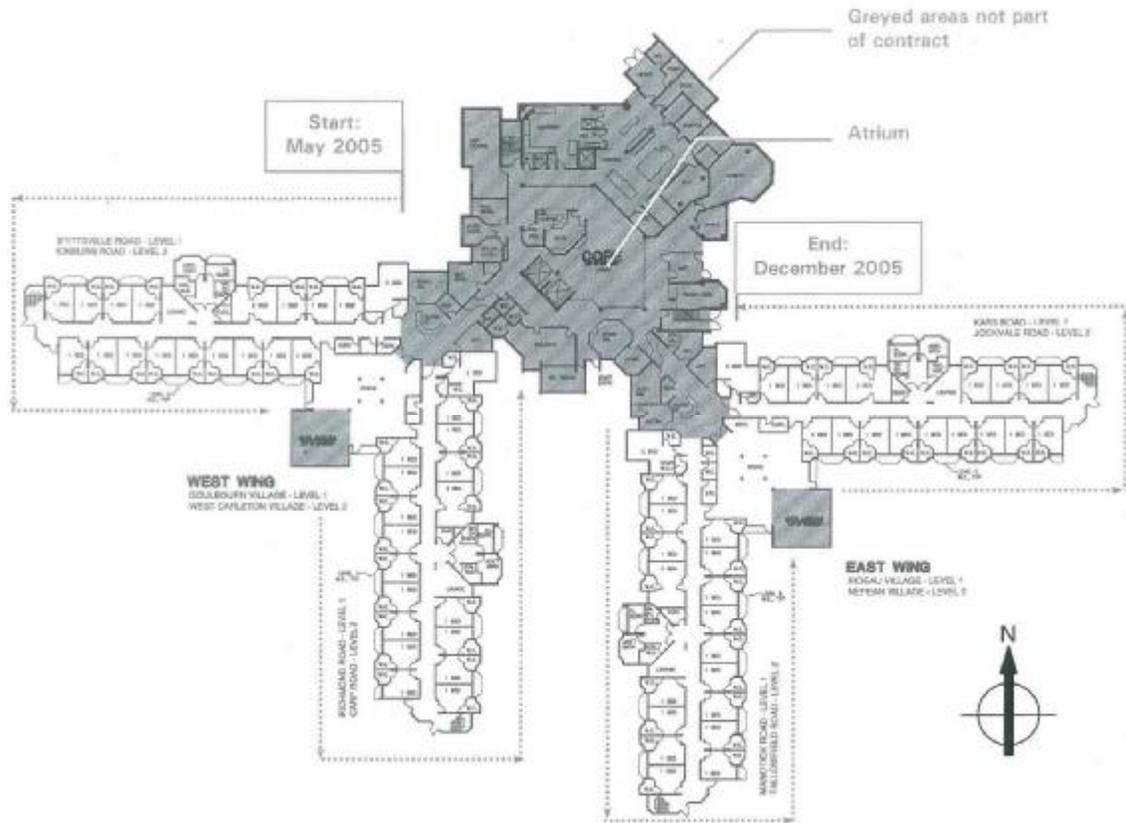
Figure 1: Building Plan

Carleton Lodge has a three-storey central core, with a large central atrium and a fourth level mechanical room. The central core is a reinforced concrete structure with insulated steel stud or concrete block exterior walls. Connected to the central core are long 2-storey multi-unit residential wings that are denoted “West” and “East”, as shown in Figure 1. The residential

Exterior cladding reconstruction was only performed on the wood framed residential wings of Carleton Lodge. The central core and two solarium areas, shown in grey in Figure 1, were not part of the contract. The central core houses the administration offices, kitchen, dining rooms and gathering areas for the residents. Reconstruction was conducted commencing at the North Elevation of the West Wing, and progressed counter-clockwise around the building, ending at the North Elevation of the East Wing. The exterior work was completed within a seven-month period from May 2005 to December 2005.

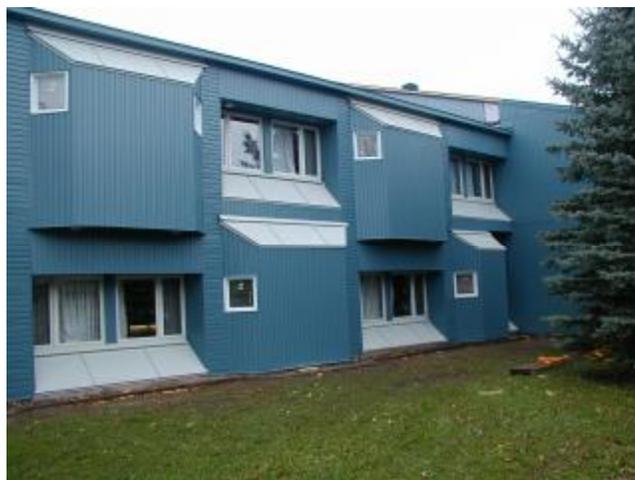
Figure 2: Retrofitted Building Elevation

wings are wood frame construction, with insulated wood stud walls and pitched shingled roofs. The residential wings have mainly private resident rooms, with some double rooms, nursing stations and assisted bath areas. Each resident room has an en suite bathroom projecting beyond the main building (Figure 2) with standing seam metal shed roofs. The second level bathrooms cantilever beyond the ground floor. The entire building is clad in pre-finished vertical aluminum siding. Two central boilers and perimeter radiators provide heat for the residential wings. Make-up air and conditioned air in the summer is ducted to the residential corridors.
