# Energy Conservation Considerations During Building Enclosure Rehabilitation of Large Multi-Unit Residential Buildings

Bonnie Dong, P.Eng.  
Government of Alberta

Warren Knowles, P.Eng.  
RDH Building Engineering Ltd.

Graeme Scott, M.Eng. P.Eng.  
RDH Building Engineering Ltd.

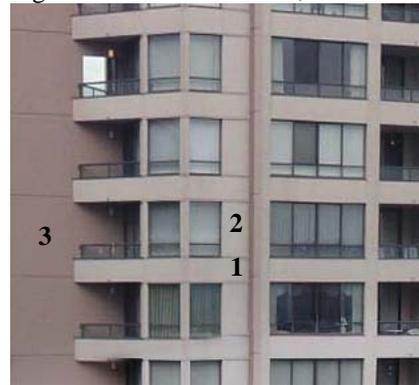
Figure 4. Typical wall assemblies:

1. Stucco over concrete upstands above/below windows,
2. Stucco over metal stud framed walls adjacent to windows,
3. Painted concrete shearwall ends / faces.

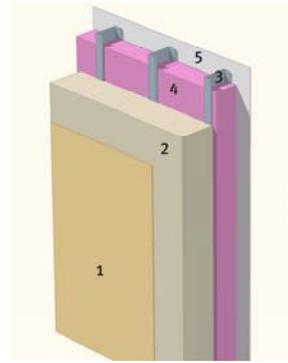
Figure 13. Isometric view of original assembly.

1. Painted exterior finish
2. Concrete wall
3. Metal studs
4. Fibreglass insulation
5. Interior gypsum board and poly

The original painted concrete shearwall assemblies and thermo stucco clad concrete upstands thermally bridged the existing interior insulation where they supported each floor slab, and where they extended beyond through the cladding assembly to form balcony and deck upstands. The shearwalls also thermally bridged the wall insulation where they projected beyond the building faces. A least cost option to manage the risk of moisture ingress in these wall assemblies, would have been to surface treat all visible cracks by injection or by routing the existing cracks and sealing with a flexible sealant, and subsequently re-

consideration of the vapour permeability of the entire wall assembly. Specifically, unlike metal stud framed exterior wall assemblies, where removal of the exterior sheathing provides access to remove an existing polyethylene vapour retarder (from the outside), the concrete wall areas can only be cost effectively rehabilitated from the building exterior. Therefore, a thermally improved, rehabilitated wall assembly was designed to manage wetting and drying effects (direct wetting/drying and vapour diffusion), with the existing polyethylene vapour retarder remaining in place. To achieve this, a vapour permeable cementitious membrane and an adhesively attached, drained Exterior Insulation and Finish System were selected (see Figures 13 and 14).
