# Partial Rehabilitation: The Challenges of Tying-in a Drained Glazing System with a Face-Seal Wall System

*A high-rise building located in Vancouver was diagnosed with water penetration at the window-wall system. The opaque walls were clad with panelized, face-sealed EIFS. The investigation found no major deterioration in the EIFS area and it was decided that the rehabilitation would include only the replacement of the window-wall system. Retaining the existing, face-seal EIFS in place brought on a number of challenges:*

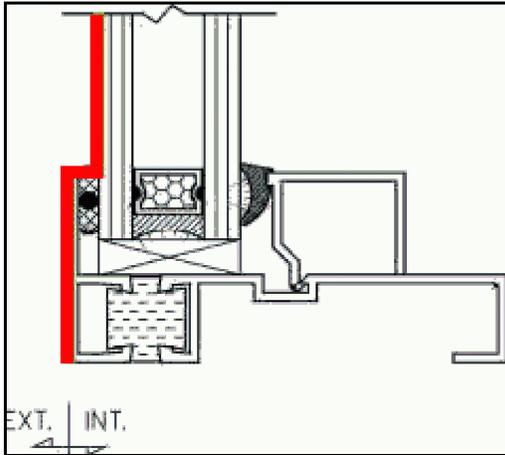
Figure 1: Face-seal window with primary exterior seal

Older window systems often used a face-sealed approach to their design. This implied that they relied on the continuity of the primary exterior seal to prevent water penetration (refer to Figure 1) and to provide the plane of air-tightness. Many of these systems have experienced water penetration problems since once the water is past the exterior seal there is no provision to contain this water or to drain it back to the exterior. This emphasizes the inadequacies of the single line of defence approach.

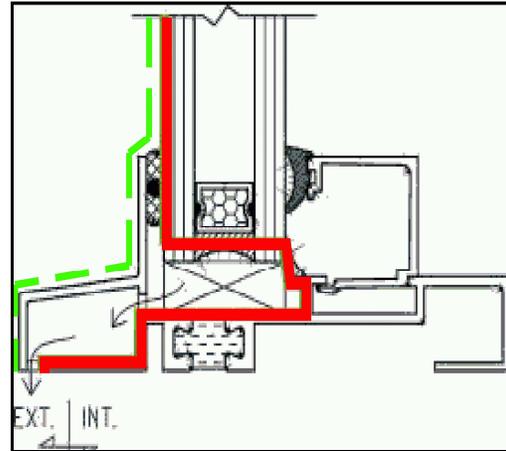
Figure 2: Drained window with primary and secondary seals

Windows, like wall assemblies, have evolved into incorporating rainscreen principles (refer to Figure 2). The rainscreen window has a secondary seal that provides both the moisture barrier and the air barrier. The secondary seal is different from the primary exterior seal (or shedding surface). It also includes drainage capabilities. With respect to the watertightness, the separation of the two critical barriers (moisture barrier and shedding surface) allows incidental rainwater that penetrates through the water-shedding surface to be contained and drained back to the exterior [5,6]. The adoption of this strategy of window design over the face-seal approach greatly improves the performance of a window system.
