Results on Assessing the Effectiveness of Wall-Window Interface Details to Manage Rainwater

M. A. Lacasse¹, M. Manning¹, M. Rousseau¹, S. M. Cornick¹, S. Plescia²,
M. Nicholls¹, S. Nunes¹

¹ Institute for Research in Construction, National Research Council Canada,
1200 Montreal Road, Building M20, Ottawa, ON, K1A 0R6;
Michael.Lacasse@nrc-cnrc.gc.ca

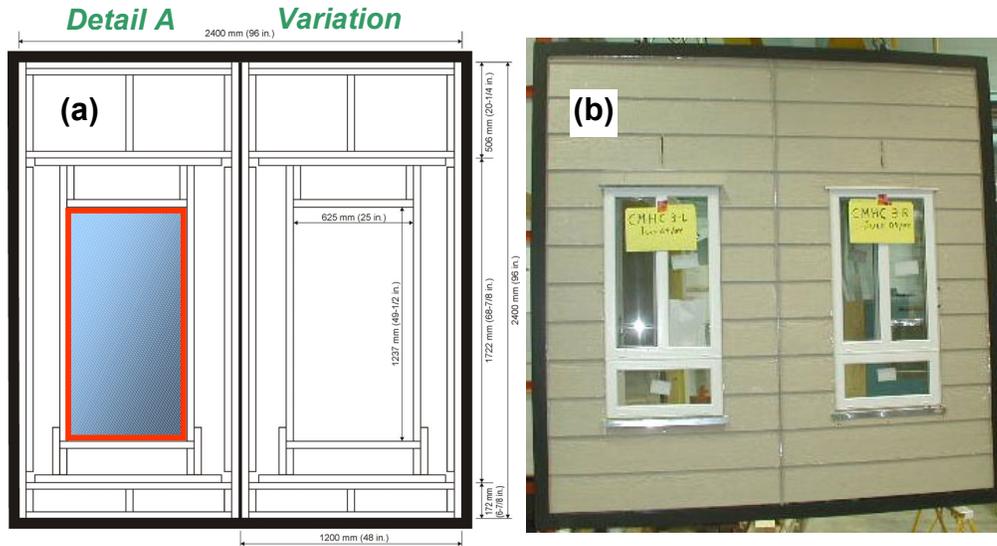
Figure 1 – (a) schematic of front elevation of 2.44-m by 2.44-m specimen showing location of 600 mm by 1200 mm windows and adjacent wood framing studs. Detail “A” might be representative of installation details used in current practice whereas detail “V” a variation on that practice; (b) photo of the completed specimen clad with hardboard siding.

Accordingly, the configuration of test specimens was established that nominally permitted comparisons among the different details when subjected to simulated wind-driven rain conditions. Wall specimens were designed to permit side-by-side comparison of two wall-window interfaces details (Figure 1). Hence, each 2440 mm by 2440 mm wall specimen included two large openings of 625-mm by 1250-mm, in each of which was placed a 600 mm by 1200 mm window together with a set of wall-window interface details. These details include those located at the window head, the jambs and the sill. Half the specimen included a “selected practice detail”, the other a “variation”, which typically could be an “upgrade” of the interface detail that may or may not be common but nonetheless presented a research interest. Entry of water around either window opening was collected in troughs located beneath the respective sills. Water was also collected at the window, just beneath the sill level, on the interior side of the specimen. Thereafter, a choice was made as to which window-wall combinations to evaluate based on regional considerations of current practice and variations thereof. Additional details regarding the test specimen configuration specific to the results reported are provided below.

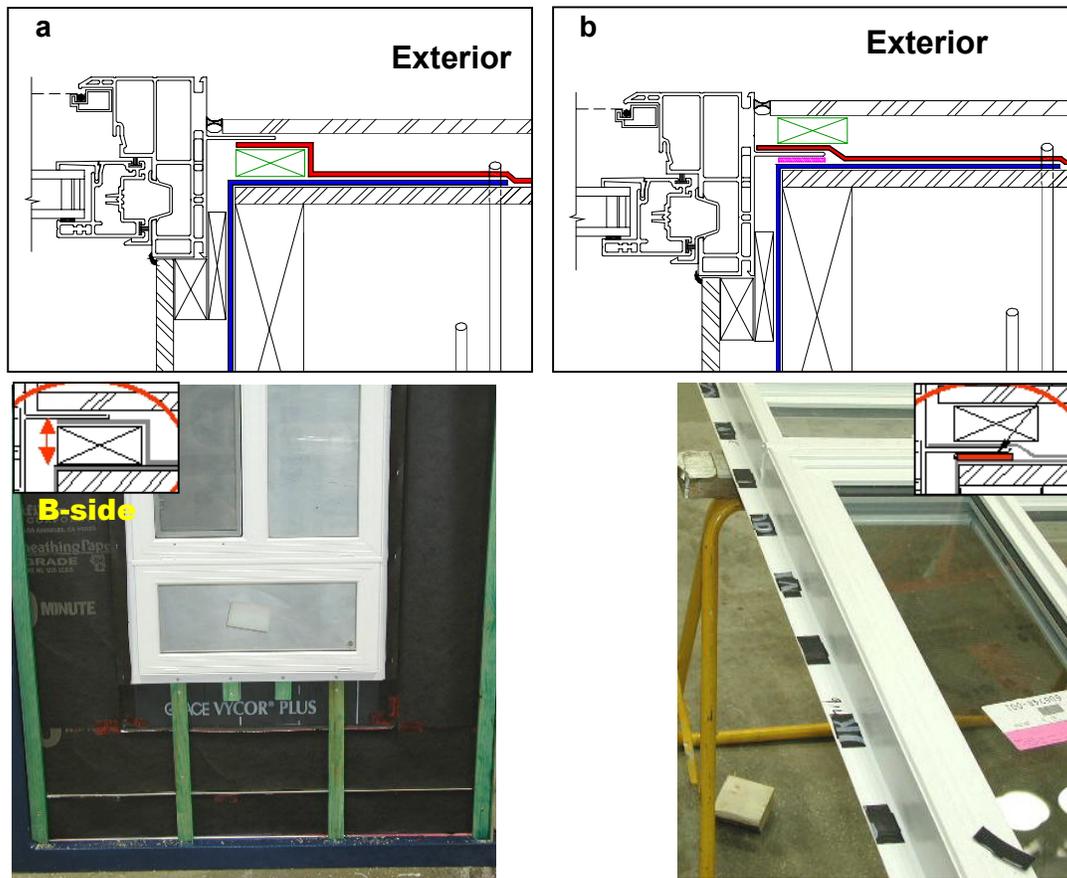
Figure 2 - Horizontal sections: (a) “B-side” window and photograph (below) showing installation on furring strips; (b) variation (“V-side”) window and photograph (below) showing membrane shims on backside of mounting flange.

Specimen W3 included PVC combination windows (horizontal sliding upper portion of 800-mm height, CSA rating B3; fixed lower portion of 400-mm height, CSA rating B4; total assembly not rated), having integral mounting flanges that were installed in a rainscreen wall incorporating a 19-mm clear cavity behind the cladding. The hardboard siding was affixed to 19-mm pressure-treated furring strips, the strips fastened to 2-in. by 6-in. (38-mm by 138-mm) wood frame studs. The rough opening at the sill was protected with strips of bituminous-based self-adhered membrane: one membrane covered the rough sill, the bottom of the rough jambs, and extended 150-mm over the sheathing membrane below the subsill. A second strip of self-adhered membrane covered the bottom 150-mm of the rough jambs and a 150 mm wide band of sheathing board. A paper-based asphalt impregnated product used for the sheathing membrane, was also used to protect the remaining portions of the rough opening extending along the height of the jambs and across the head of the window. Of the two different installation methods, the specified practice (“B-side”) included installation of the window directly on the furring strips, as shown in Figure 2 (a). The variation of this detail (“V-side”), shown in Figure 2 (b), has the window flange mounted to the protected sheathing board on the backside of which were placed shims (shown in photograph) that provided a small space (2-3-mm) between the mounting flange and the board.

The shims were made of small portions of bituminous-based self-adhered membrane that had been folded over and applied to the flange at fastener locations. Following window installation, sheathing membrane was loosely installed (no seal) over the window flange at the head and jambs and beneath the window flange at the windowsill. Drip cap flashing (rigid PVC), not incorporating end-dams, was installed at window heads whereas rigid metal flashing, serving as sill drip cap, was placed at the junction of the window and cladding. The 6-mm joint between cladding and window frame was sealed with a backer rod and sealant.

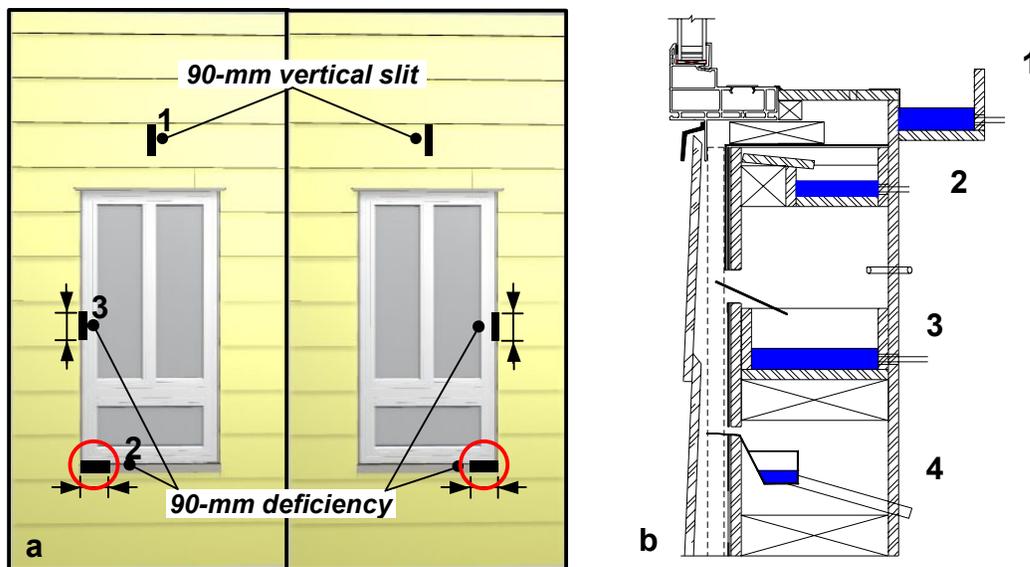
Figure 3 – Front elevation of 2.44-m by 2.44-m specimen (cladding exterior) showing location of 90-mm deficiencies (missing sealant, backer rod at specimen face); (b) Vertical wall section (inter.) showing location of water collection troughs at (1) window on interior side of test specimen, (2) beneath window in false subsill; (3) beneath subsill for collection of water drained from subsill (see Fig. 4) and, (4) lower most trough for collection behind siding [14].

Three (3) sets of deficiencies were incorporated at the interface between the exterior cladding and the window frame and included: (1) 90-mm vertical slit (ca. 2-mm width) above window heads; (2) 90-mm missing length of sealant and backer rod located at the horizontal joint along the lower and outer corner of the window frame, at the junction of the window frame and the sill flashing, and; (3) a 90-mm long by 6 mm wide missing sealant and backer rod in a vertical joint at mid-height of the outer window jamb. Each of these locations is identified in Figure 3.

Water penetration at the window proper, entering unintended openings in the cladding and interface, or entering through deficiencies, was collected in troughs located as shown in Figure 3 (b). A trough located at (1) in Figure 3 (b) permitted collecting water that would penetrate the window between the lite and window frame; water accumulating at the sill could be collected in a false sill trough at (2), or in a trough located beneath the sill at (3) which measured water drainage from the sill to the trough; water finding its way behind the cladding would be collected near the base of the wall in the trough at (4). Nominally, this permitted quantifying the amount and rate of water entry along different paths and differentiating the significance of these paths given different test conditions. For example, water entering the subsill area, as shown in Figure 4, would drain from the subsill down the front of the waterproof membrane and be directed into collection trough (2) beneath the subsill. As shown in the figure, water was redirected to this trough using a protruding metal plate that was placed in a horizontal opening, a narrow slit, located ca. 180-mm below the sill edge.

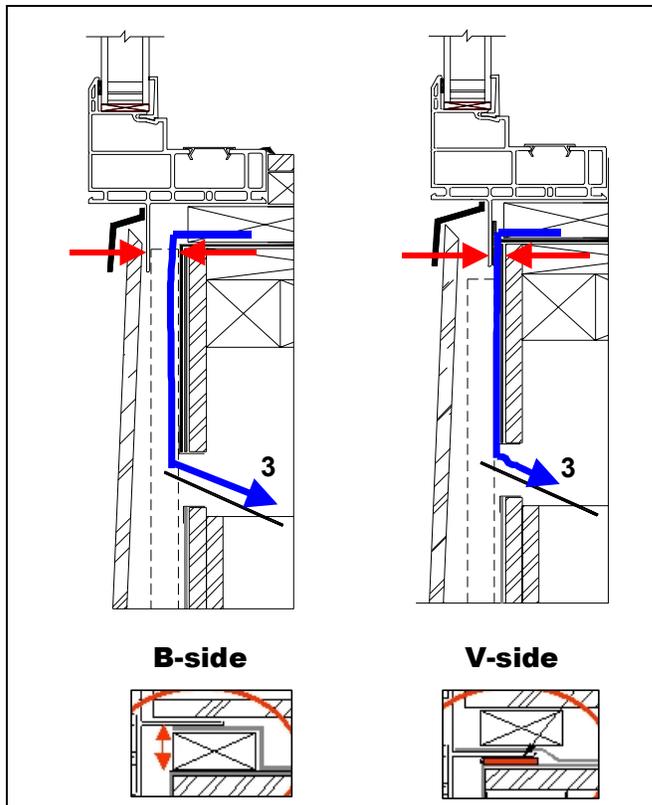
Figure 4 – Expected direction of water drainage from subsill to collection trough (3) for base-case (B side) and variation (V-side) portions of specimen W3

Water collection in the trough beneath the subsill (see Figure 4, trough (3)) indicated substantial amounts of water entry for the V-as compared to the B-side of the specimen. As shown in Figure 6, at the lowest rate at which water was deposited on the cladding (i.e. 0.8 L/min.-m²) there was no water collected on the B- as compared to the V-side, the rate of collection in trough (3) over the applied differential pressure across the specimen not exceeding ca. 20 ml/min. At a water deposition rate of 1.6 L/min.-m² only the V-side registered water entry, comparatively substantial amounts ranging from ca. 100 to 140 ml/min being collected. At 3.4 L/min.-m², the highest cascade rate tested, water entry was recorded for both sides of the test specimen and ranged from ca. 60 to 190 ml/min, the peak occurring on the V-side, at 150 Pa pressure difference. Notably, water was collected when no pressure was applied across the assembly at substantial rates, upwards of 100 ml/min for the B-side. The entry rates were not dependent on changes in pressure; however, changes in water cascade rate did bring about increases in rates of entry to the collection troughs.

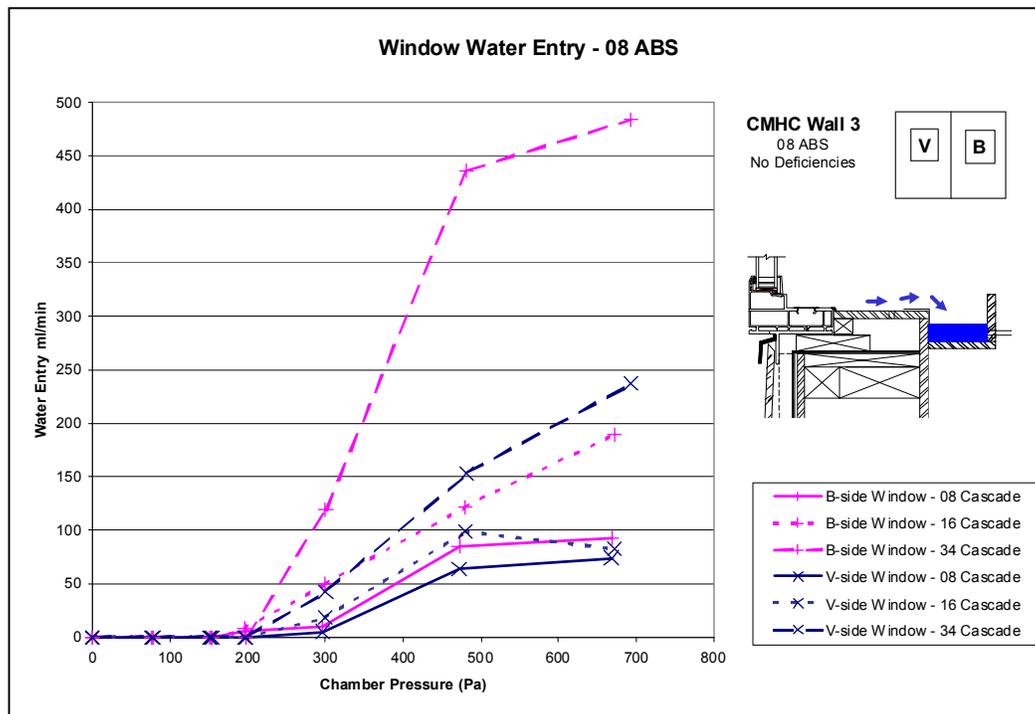
Figure 5 – Water collection rates to trough located at window of specimen W3 (Figure 3 (c) – trough (1)); collection rates (ml/min) are shown in relation to pressure differential (“chamber pressure”) across test specimen (Pa) for both B- and V-side of specimen at different water cascade rates for which, for example, “08 Cascade” refers to nominal cascade rate of 0.8 L/min·m². The test was conducted for a specimen having an ABS leakage of 0.8 L/s·m² at 75 Pa.

Results from tests in which no deficiencies were introduced on the specimen indicated very little or no water entry to the sub-sill area or behind the cladding for either the B- or V-side of the specimen. However, above a differential test pressure of 200 Pa, water entry at the windows increased substantially. This might have been expected given the sliding window used in the upper part of the combination window; the sliding window is rated as CSA B3 (i.e. 300 Pa). As shown in Figure 5, at the highest differential pressure and water cascade rate (i.e. 700 Pa and 3.4 L/min-m², respectively) water entry at the window of the B-side was roughly double that of the V-side up to a maximum of 484 ml/min on the B-side, and 237 ml/min on the V-side. As well, above these pressure levels, the rate of water entry for either side was dependent on both, increases in water cascade rate and increases in pressure differential. The difference in entry rates across windows that nominally have the same expected performance rating is perhaps due to the

difference in respective water loads at the face of the window proper. These loads are typically affected by any protrusions from the cladding plane be they the window profile or drip cap flashing placed at the head of the window. Both windows had head flashing however, the window on the B-side projected out from the cladding plane to a greater extent (~ 16-mm) than the window on the V-side; hence, the B-side window may have been exposed to a more substantial water load accounting for the increased entry rates on the B-side as compared to the V-side at the window.

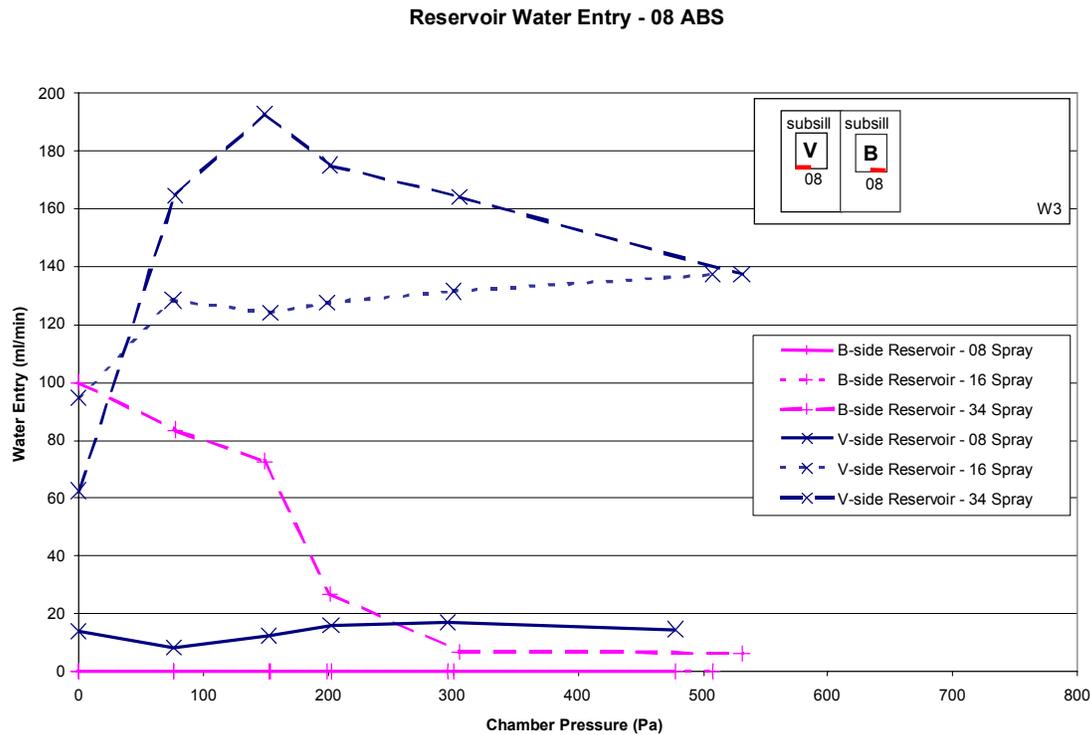
Figure 6 - Water collection rates to trough located beneath subsill (Figure 4 – trough 3) for both B- and V-side of

specimen W3. Collection rates (ml/min) are shown in relation to pressure differential (“chamber pressure”) across test specimen (Pa) at different water cascade rates for which, for example, “08 Cascade” refers to nominal cascade rate of 0.8 L/min.-m². The test was conducted for a specimen having a nominal ABS leakage of 0.8 L/s-m² at 75 Pa.

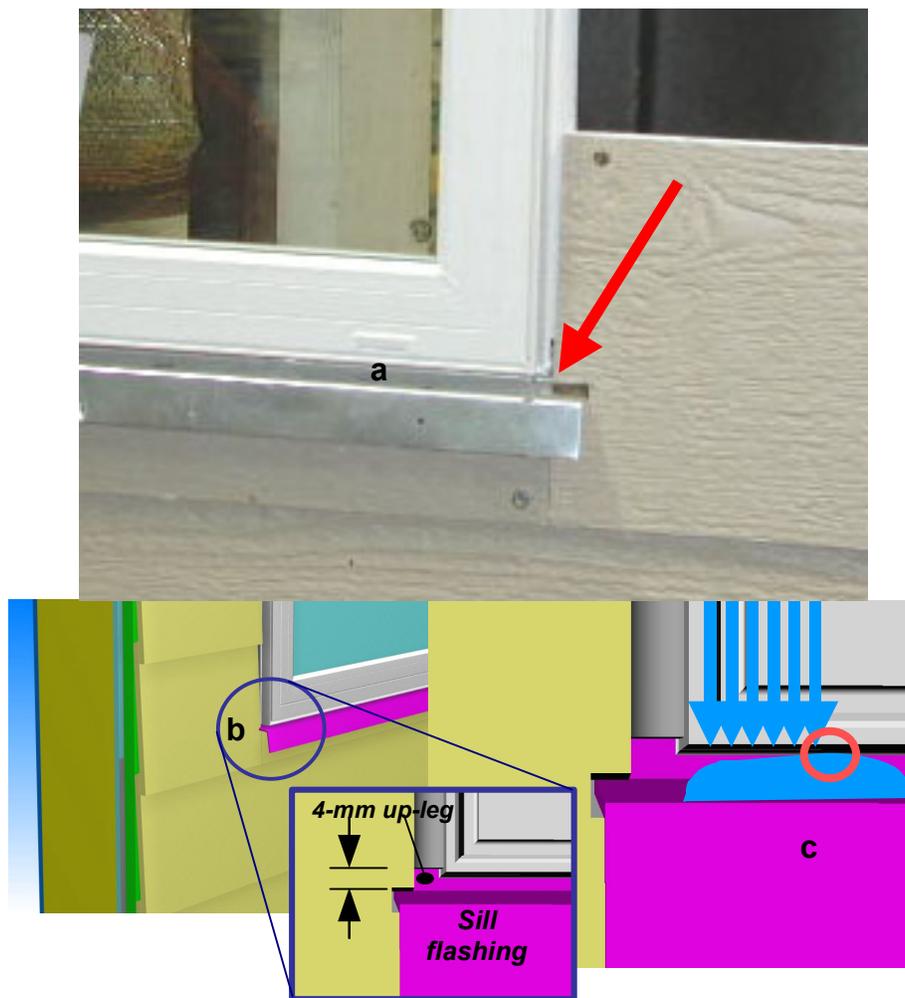
Figure 7 – Variation-side of specimen W3 and details of deficiency at (a) lower corner of window-cladding interface; (b) details of sill flashing showing 4-mm up-leg and; (c) water accumulation at sill flashing.

Figure 7 (a) shows the lower corner details at the cladding-window interface and (b), the 4-mm flashing up-leg. Water ran down the window face and, given the shallow slope of the sill flashing, pooled on the protruding flashing. Access to the back of the flashing was possible since the sealant and backer rod were removed at this location. Hence, the “pooled” water accumulated at this location and readily surmounted the ~ 4-mm flashing up-leg.

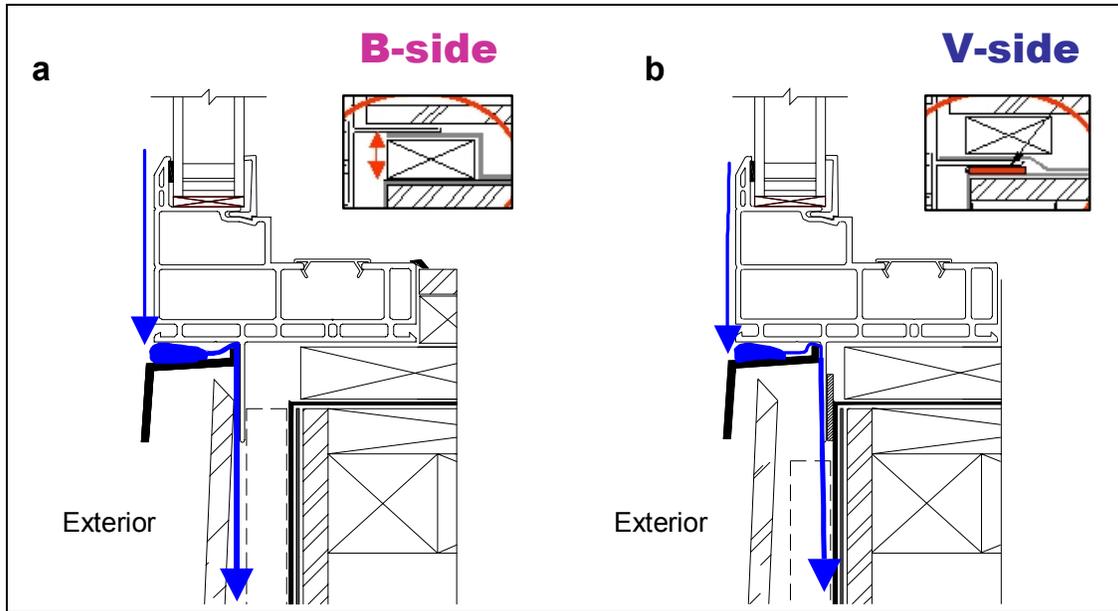
Figure 8 – Vertical section at wall-window interface of (a) selected practice B-side and; (b) Variation, V-side of specimen W3 showing path of water entry from exterior towards the interior and behind cladding.

Figure 8 shows a vertical section at the wall-window interface for both the V- and B-sides of specimen W3. On the V-side (Figure 8 (a)), water surmounts the up-leg and passes behind the rigid sill flashing, running down the window mounting flange. However, the proximity of the mounting flange to the backup wall allows water to bridge the 3-mm gap created by the shims at the back of the window flange. As shown in Figure 8 (b) for the B-side, water follows similar path as on the V-side although the 19-mm gap created by the furring placed behind the cladding

proves difficult, but not impossible to bridge. In both cases, a portion of water attains the backup wall and is collected by trough, with the remainder running down the interior of cladding and is collected at the base of the wall. However, given the smaller gap of the V-side as compared to the B-side (3-mm / 19-mm) and the relative ease for water to bridge the smaller gap, implies that the V-side contributed to a greater amount of collection on this side of the specimen.
