Assessing the effect of attic moisture in wood framed multi-unit row housing blocks.

Rene R. Boucher

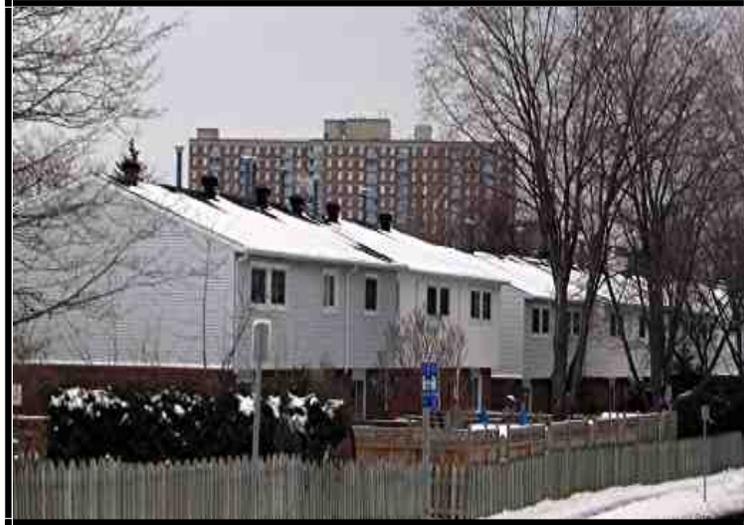
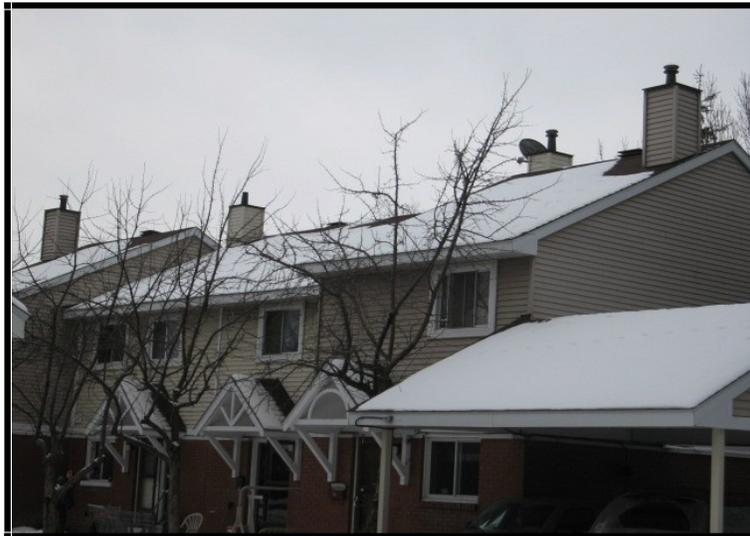
be a serious problem. It arrives from two directions: from the inside of the house as warm air rises and condenses on the underside of the roof deck and from the outside as water leakage through failed shingles, or from underneath the shingles as melted snow backs up as a result of ice damming at the eaves, and building offsets due to elevation and grade changes. In addition to water damage, any moisture in the attic can be the start of a serious mould and roof deterioration problem – dangers both to your health and to your investment.

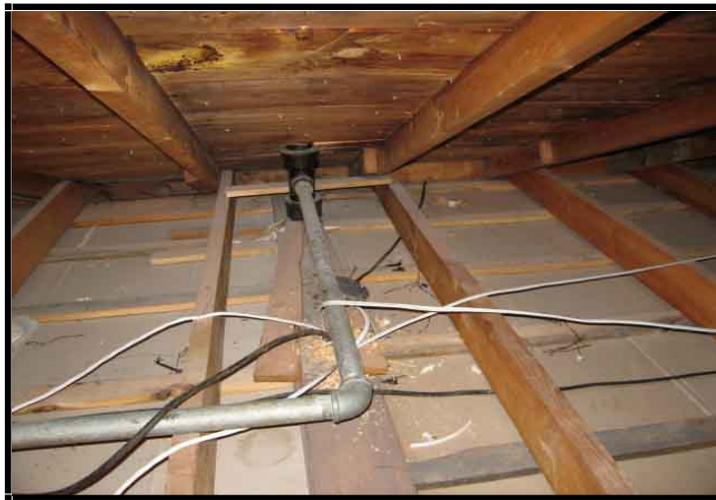
Unknowingly, the roofing industry was making the wet-attic situation worse. How? They were following the correct procedure for ventilation, but solving only part of the problem instead of the whole problem. Ventilating a previously unventilated attic has the effect of making the attic colder. If nothing is done to stop warm, moist air from entering the attic space from the living space, condensation on the now-cooler surfaces is a certainty. Mold, mildew, and eventually leakage into the living space will probably follow. Insulation contractors, armed with the same lack of information about attics as the roofers, have caused similar problems. Insulating the attic floor makes the attic colder in the same way as adding ventilation. But, if contractors don't seal as well as insulate, they don't stop warm, moist air from entering the attic and causing big problems.
