Variations in Position of Columns and Slabs

James B. Posey

ABSTRACT

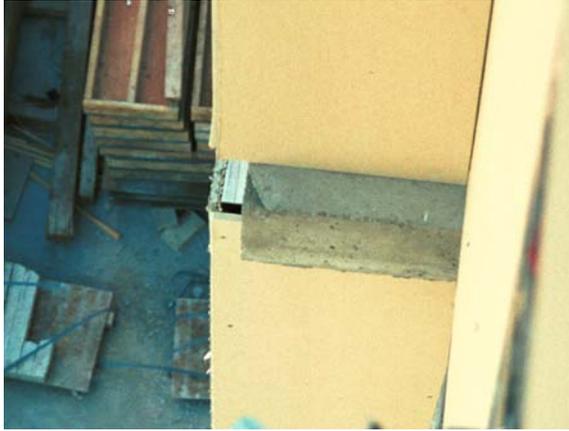
Illustration 1: Walls and supporting slab misaligned; on one side the slab projects from the wall sheathing, on the other it's retracted. The same detail applies to both—the designer envisioned the slab edge and face of sheathing in alignment.

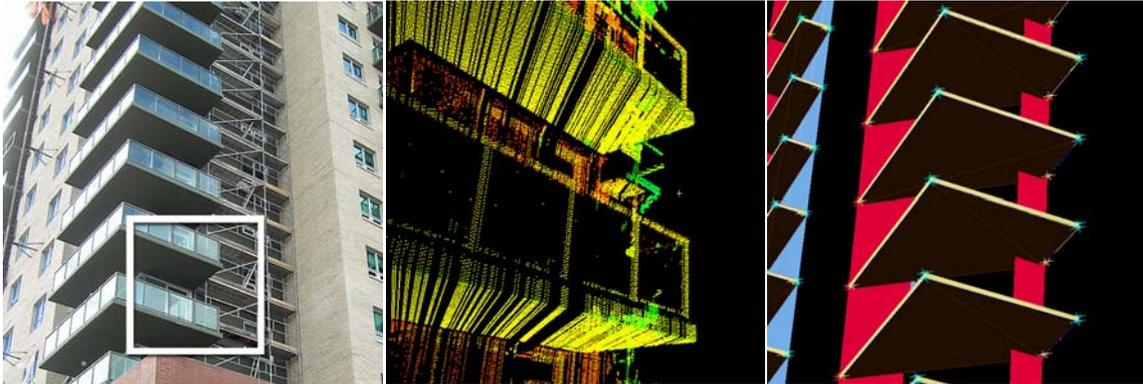
Illustration 4: Building 1: Photograph of balconies; outline shows extent of Illustration 3.

Illustration 2: Building 1: Detail of point cloud; colours indicate strength of return signal.

Illustration 3: Building 1: 3D Geometry of fitted planes and resulting vertices.

The methods of measurement, and elements measured varied. Building 1 was a recently constructed residential building with exposed CIP balcony slabs. A Leica Geosystems HDS3000 3D laser scanner was used to capture two point clouds. Cloud-to-cloud alignment in software was used to merge the data. Least-squares fits to the point data from visible slab edges and soffits defined a plane for each visible balcony slab surface, and the geometry of the fitted planes was exported to a DXF file using the vertical intersection between two large walls to orient the vertical coordinate. Sub-sets of points were selected that, assuming the balconies were intended to be aligned, ought to have been connected by vertical lines. For each such vertical stack of points on a stack of balconies, linear regression determined if the best fit was parallel to the selected vertical axis, and indicated that it was—typically within one mm. From the point locations, offsets between adjacent floors were determined and all the offsets were grouped into a single dataset for analysis.

The manufacturer's specified standard deviation (represented by sigma, σ) for points is 6 mm at a distance of 50 m with this scanner (it would vary with angle of incidence and distance). However, if the assumption that slab edges and soffits are plane surfaces is accepted, the standard deviation of measurement is reduced, typically to 2 mm.

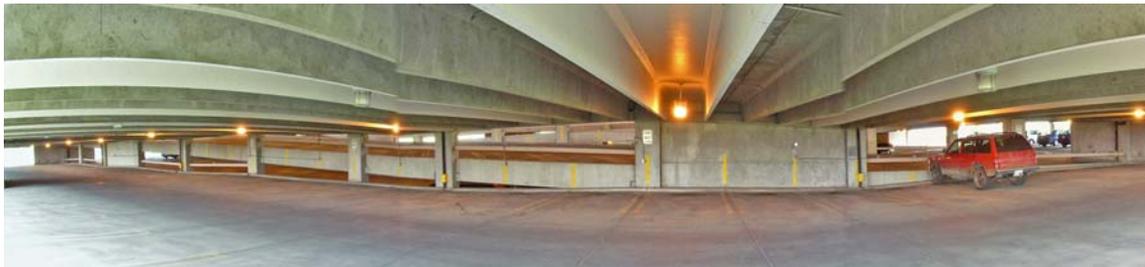
Illustration 5: Building 2: Panoramic view of interior.

Building 2 was a precast concrete (PC) parkade. Spacings between faces of columns were measured with a Leica Disto 5a laser distance meter, and the data were grouped into sets of column pairs that were evidently intended to be identically spaced. The manufacturer states the accuracy of this device to be ± 1.5 mm. When it was fixed relative to a target, repeated

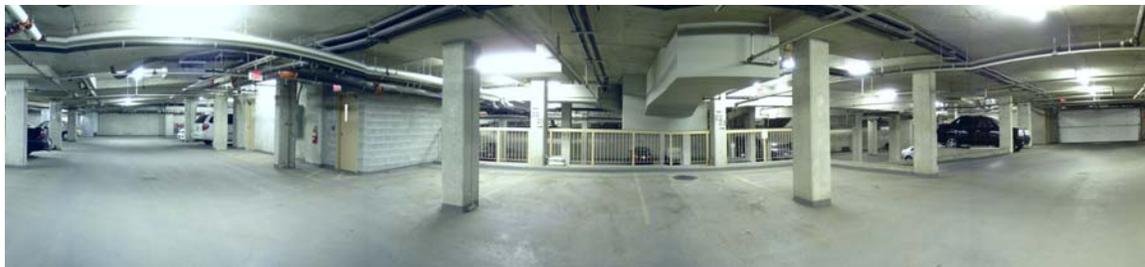
Illustration 6: Building 3: Panoramic view of interior.

Building 3 was an underground CIP parkade in a recently constructed high-rise residential building. The laser distance meter was used to measure column spacings, and data were grouped in the same manner as for Building 2.

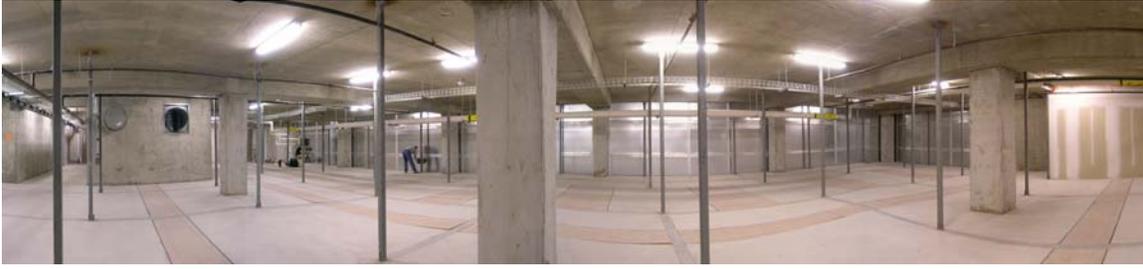
Illustration 7: Building 4; Panoramic view of ceiling space, measurement in progress along curtain wall in background.

Building 4 was a recently constructed CIP frame laboratory building that was unfinished on the interior. It had interstitial ceiling spaces with floors of CIP topping on metal deck in a structural steel frame suspended on HSS hangers supported by the CIP floor above. From the ceiling space, it was possible to access the gap between the exterior aluminum curtain wall and the CIP concrete floor slab.

Adjacent to the CIP slab edge and curtain wall, a laser was set up to project a fixed horizontal reference line more-or-less parallel to the wall. Although stability was necessary, the accuracy of the reference line is not relevant, because the analysis of the resulting data looks only at variation from least-squares-fitted lines, and does not address whether the slab was horizontal, or if the wall was at the intended location and alignment.
